NATIONAL  
TRUST  
FOR  
HISTORIC  
PRESERVATION®

# Repair or Replace Old Windows

**A Visual Look at the Impacts**

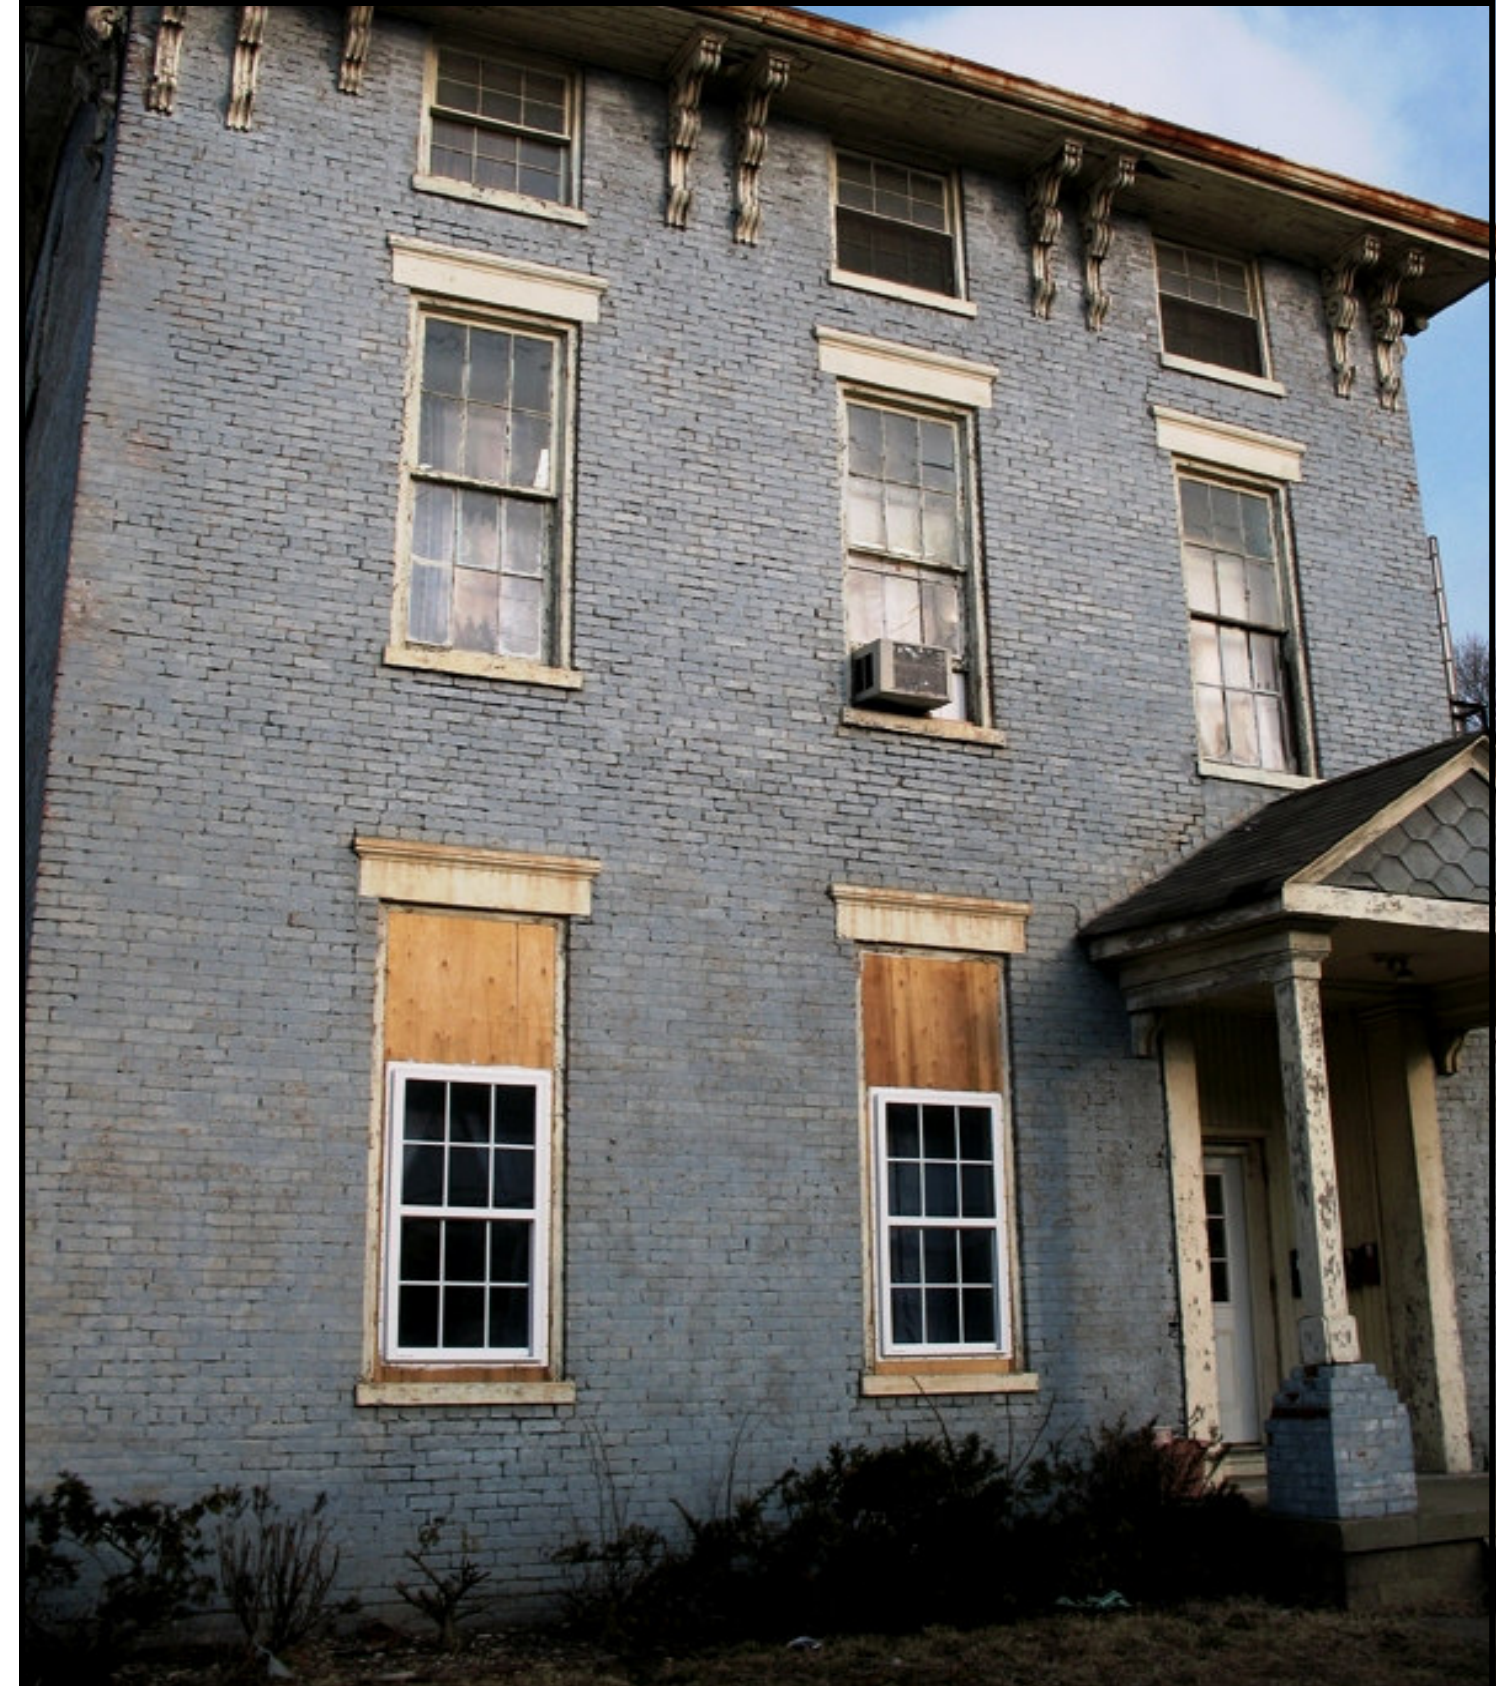
### 19th century Italianate style house Replacement windows do not match size, type or material

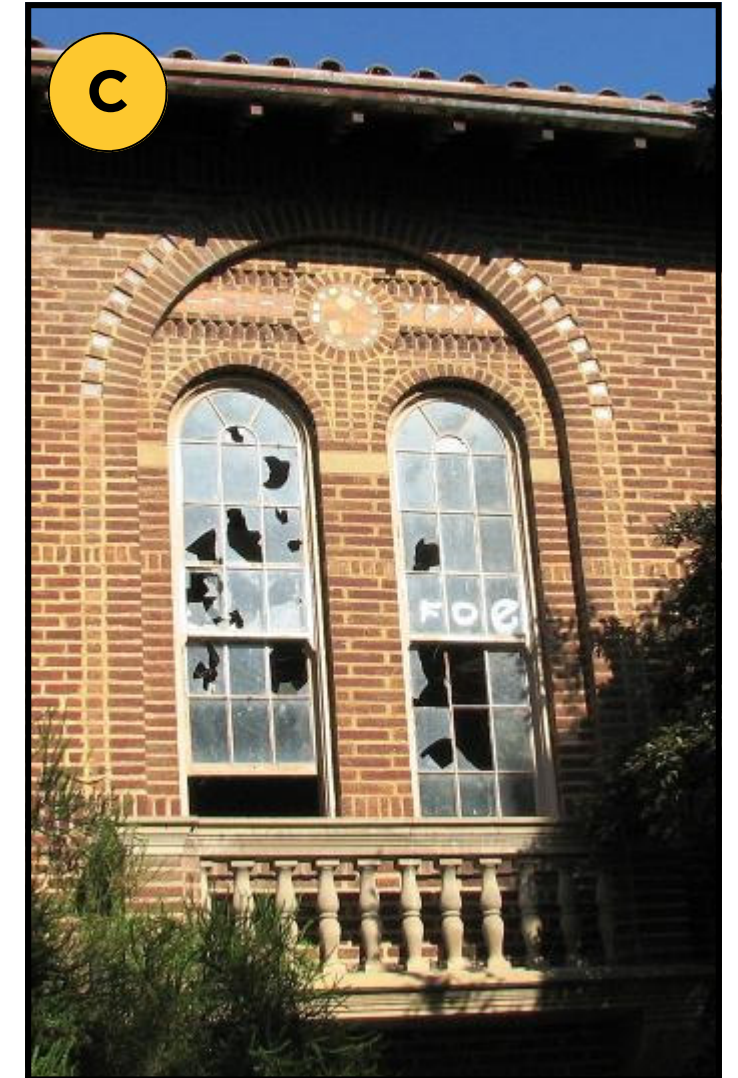
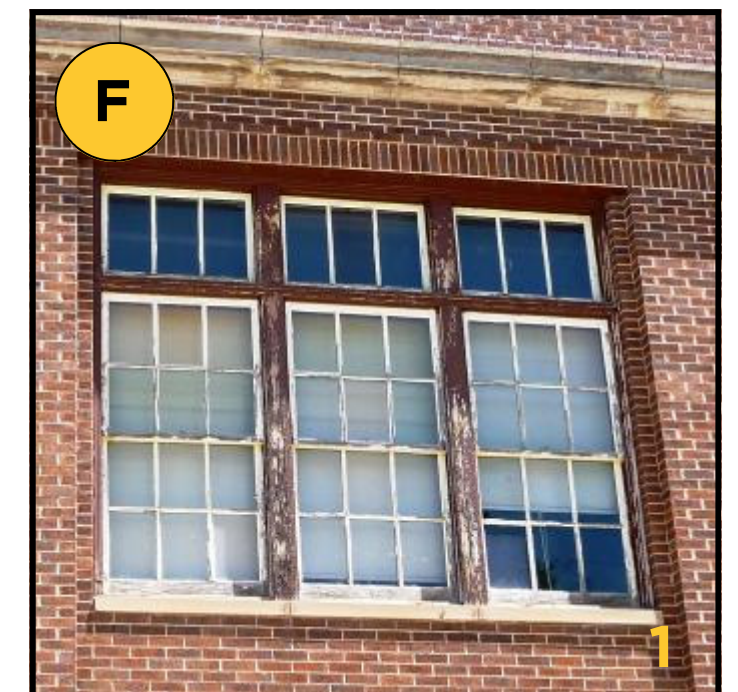
- A, B Two eight-over-eight double-hung sash dormer windows. Both are in disrepair; window A will need to be rebuilt or replaced to match window B.
- C Broken glass on these architecturally distinctive windows can be easily replaced and windows repaired.
- D A coat of paint and routine and preventive maintenance can restore windows to their original appearance.
- E Unique roof monitor with well-maintained and character defining six-over-six double-hung sash windows.
- F Group of six-over-six double-hung sash windows with transoms, only needing paint.

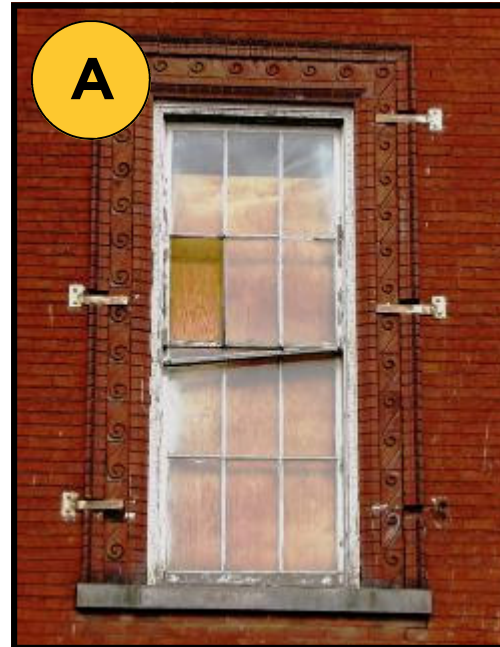
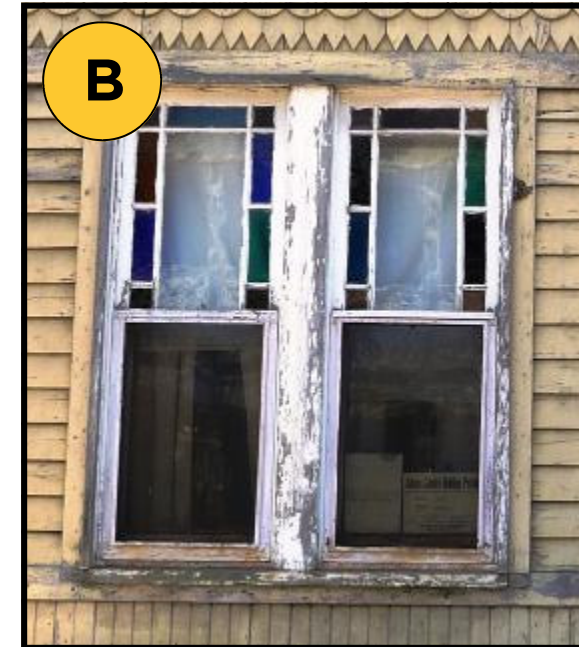
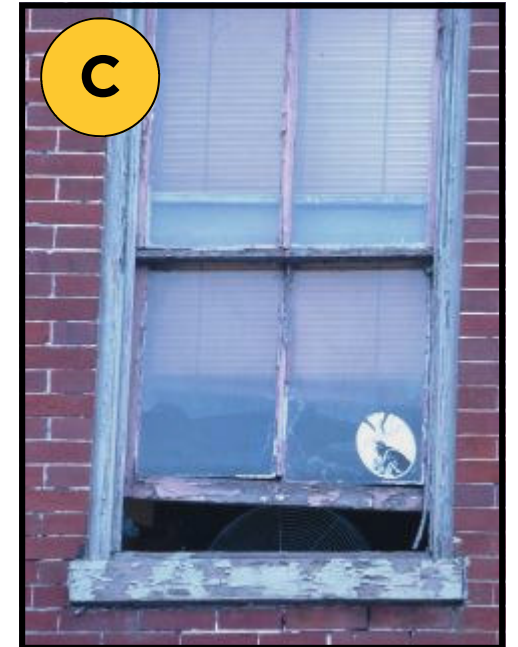
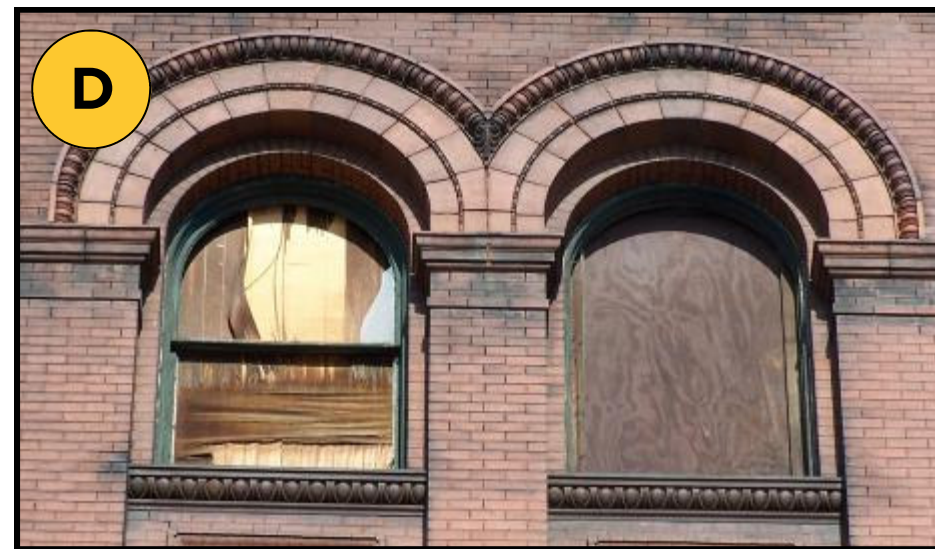
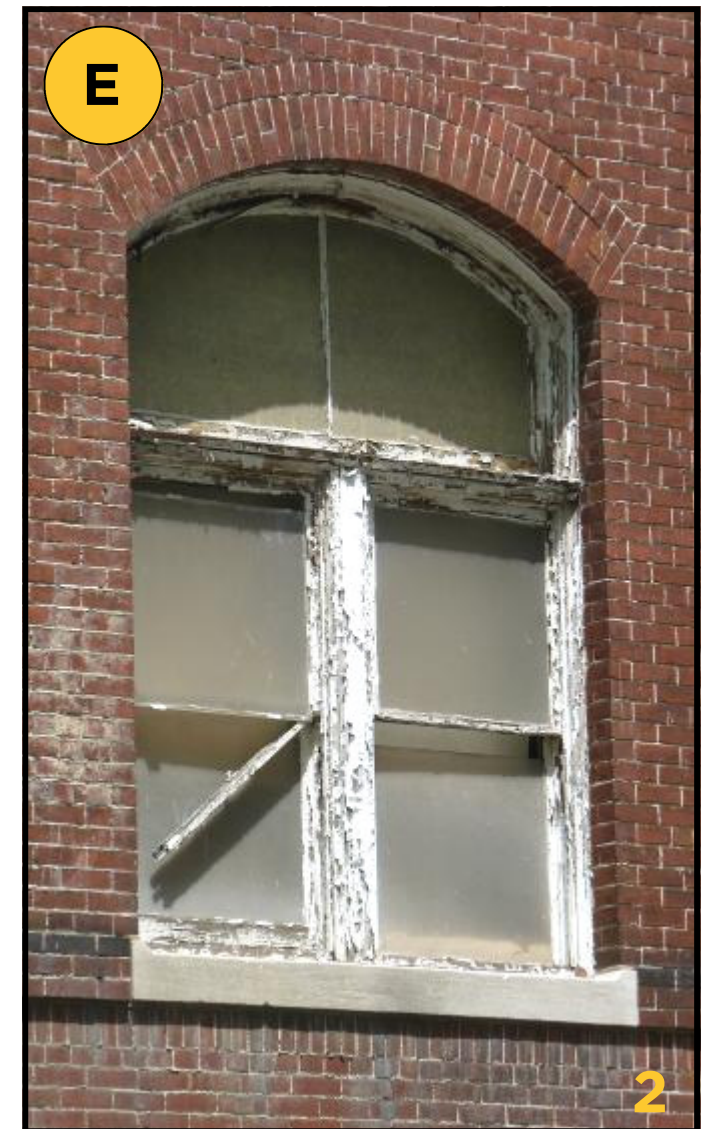
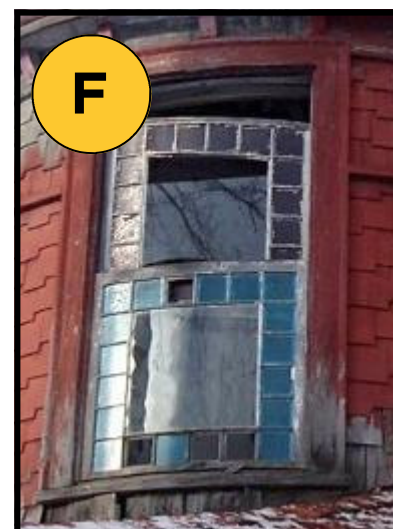
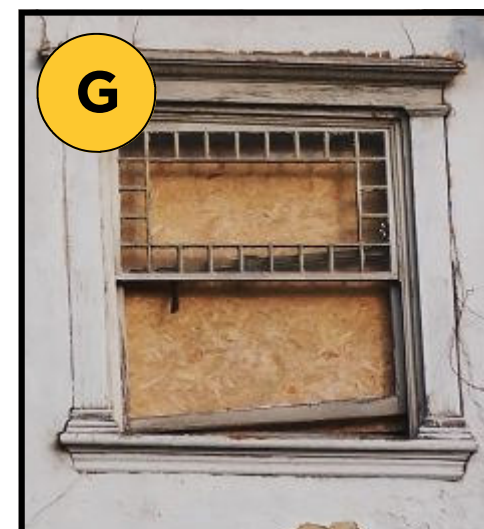
- A Six-over-six double-hung sash with loose meeting rail, missing glass — can be repaired.
- B Queen Anne windows needing paint, re-glazing — can be repaired.
- C Two-over-two double-hung sash with loose bottom rail, needing paint, re-glazing — can be repaired.
- D Arched double-hung sash windows missing glass and frames — replacement likely.
- E One-over-one double-hung sash windows and fixed transoms with detached meeting rail, needing paint and re-glazing — can be repaired.
- F Queen Anne window in poor condition, detached from frame and missing glass — borderline, requiring extensive repairs.
- G Queen Anne window missing glass and subject to structural settling of the building — borderline, requiring extensive repairs.

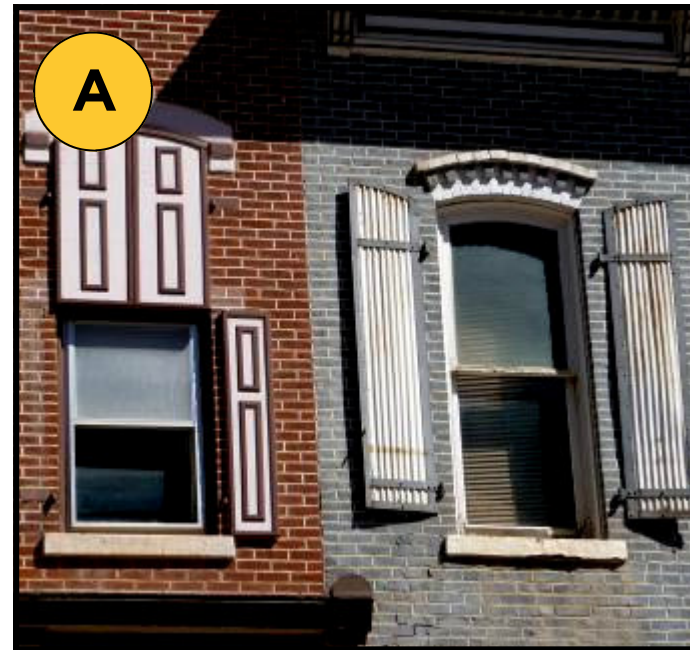
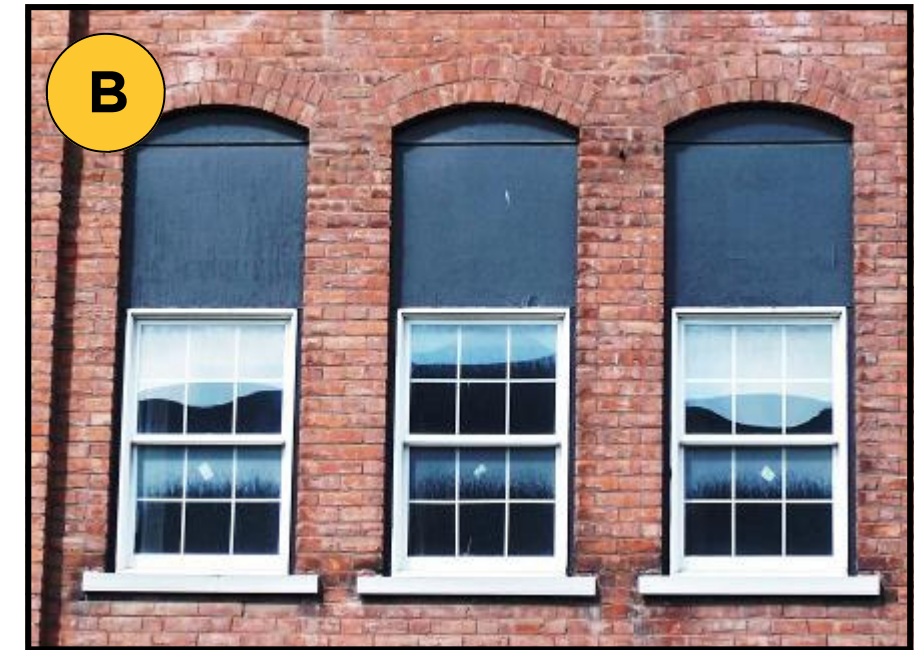
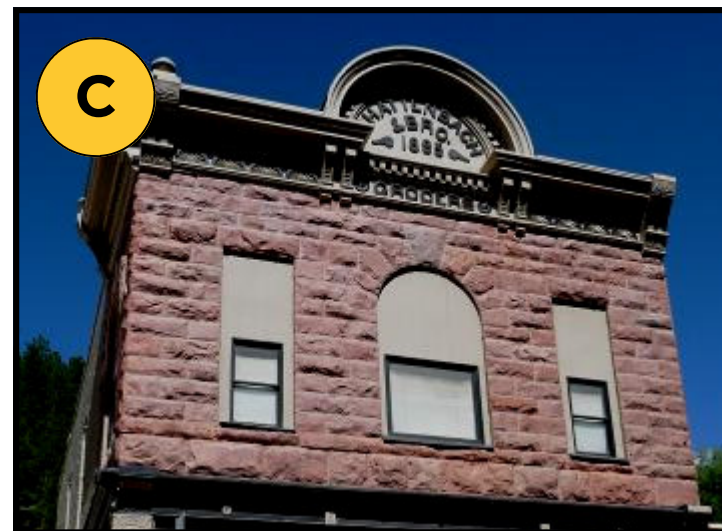
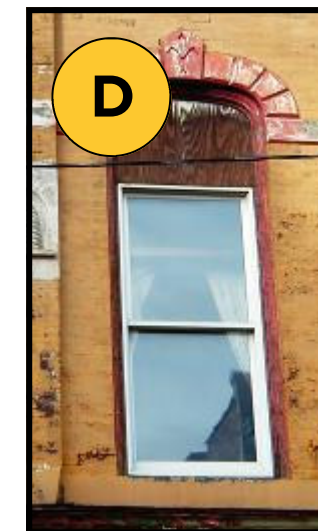
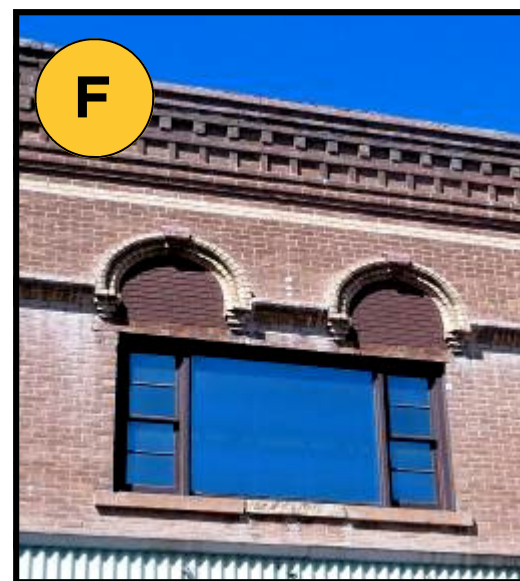
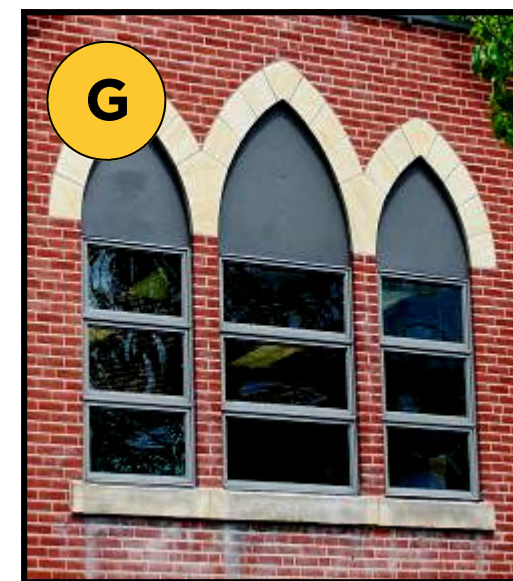
- A Italianate style row houses, side by side. Building to the right retains original arched one-over-one double-hung sash windows. Building to the left has smaller replacement windows and in-fill panels installed in the original opening.

- B Industrial building converted for housing with reduced windows and in-fill openings.
- C Main Street commercial building with upper floor windows removed, openings reduced down and much smaller replacement windows that do not match.

- D A stock, smaller window unit was used to replace a larger double-hung sash window.
- E Brick was used to in-fill the original opening of the round-arched window.

- F Two round arched windows were removed and replaced by one larger picture window, completely different in design and period to the historic Main Street building.

- G Three vertically-oriented Gothic style windows were reduced and replaced by horizontally-oriented hopper type windows.

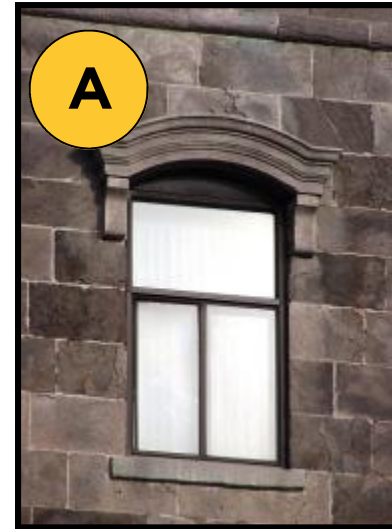
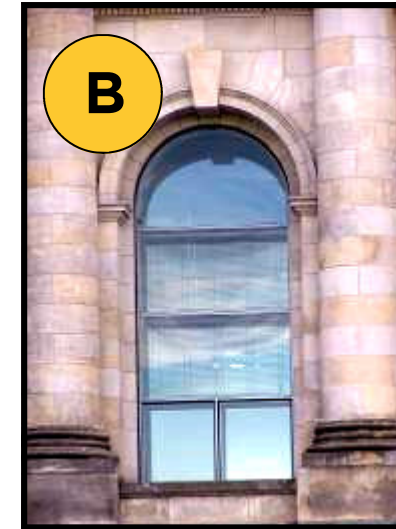
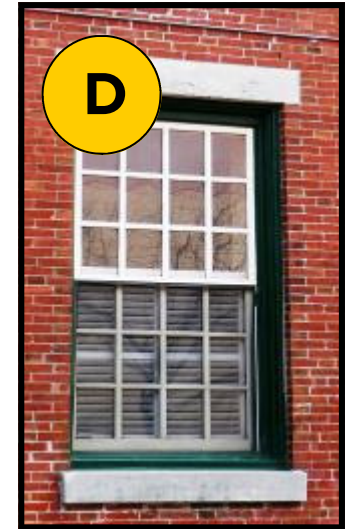
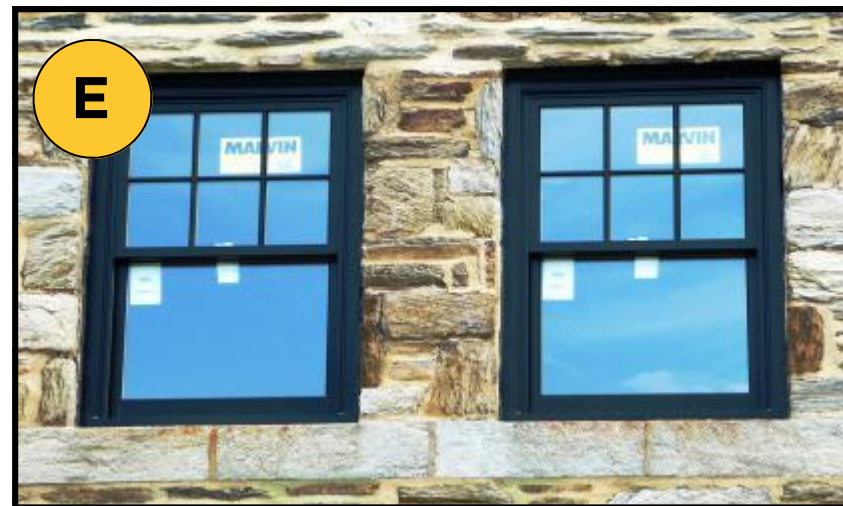
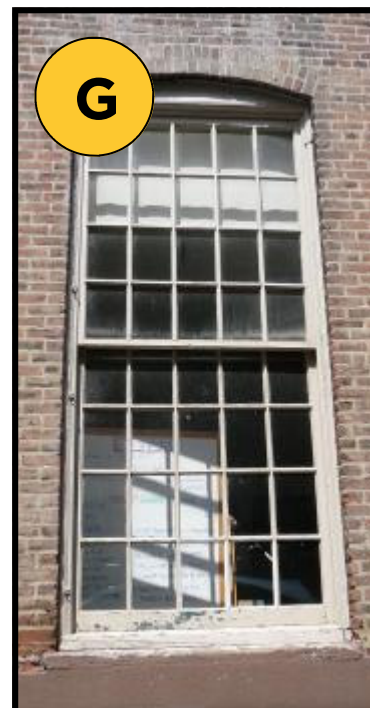
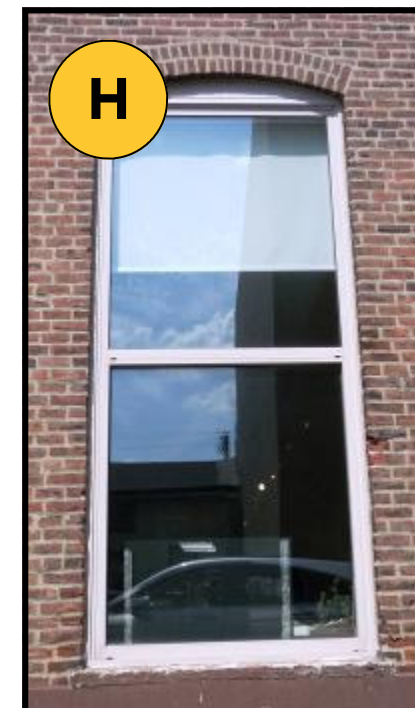
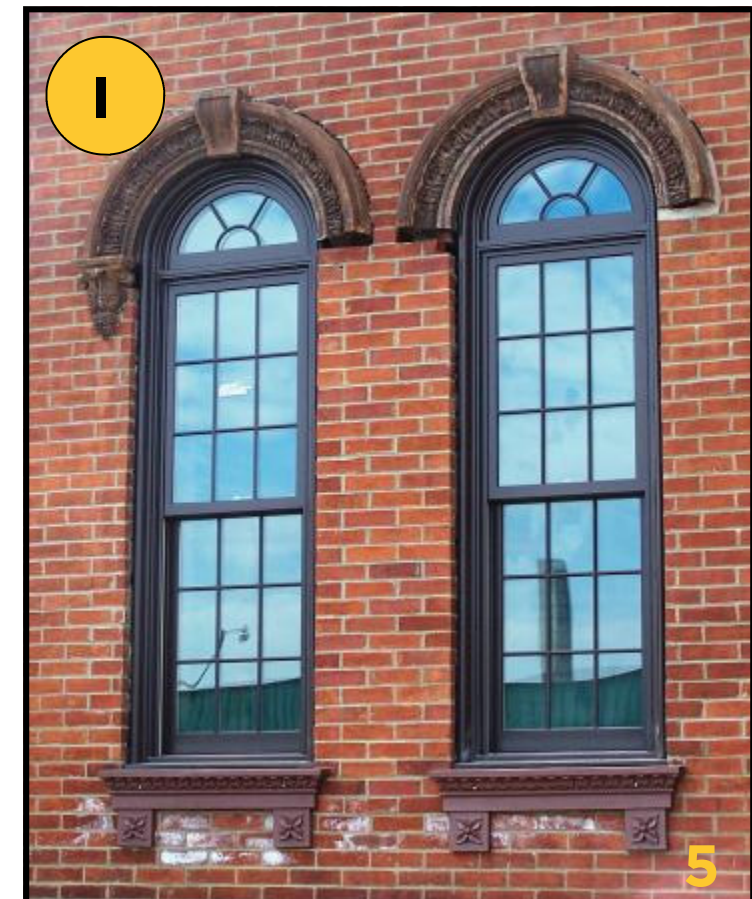
- A Replacing an original double-hung sash window with a casement and fixed transom dramatically changes the look and architectural character of this historic building.

- B Modern interpretation of an arched window alters the pattern and overall design on this monumental civic building.
- C If original windows are no longer intact, this approach may be acceptable as windows clearly reflect their own era.

- D Replacing a round arched double-hung sash window is a one-over-one double-hung sash with fixed transom. This illustrates using stock windows to fit an opening that often requires a custom or more costly replacement window.

- E The thickness of muntins as well as their profile can make a difference. This window is not a true divided-light design, instead featuring applied, flat muntins.

- F New windows will often require 'building out' and enlarging the casing and surround to accommodate a stock replacement unit, effectively reducing the size of the window in comparison to the originals.

- G The introduction of a hopper window completely alters the look of this window.
- H Window G features the original twenty-over-twenty double-hung sash window. The replacement, window H, is a fixed one-over-one unit. The design, profile and depth are altered in the process.

- I New windows attempt to replicate originals, though the casing and surround is wider and the fixed fanlight does not match originals.

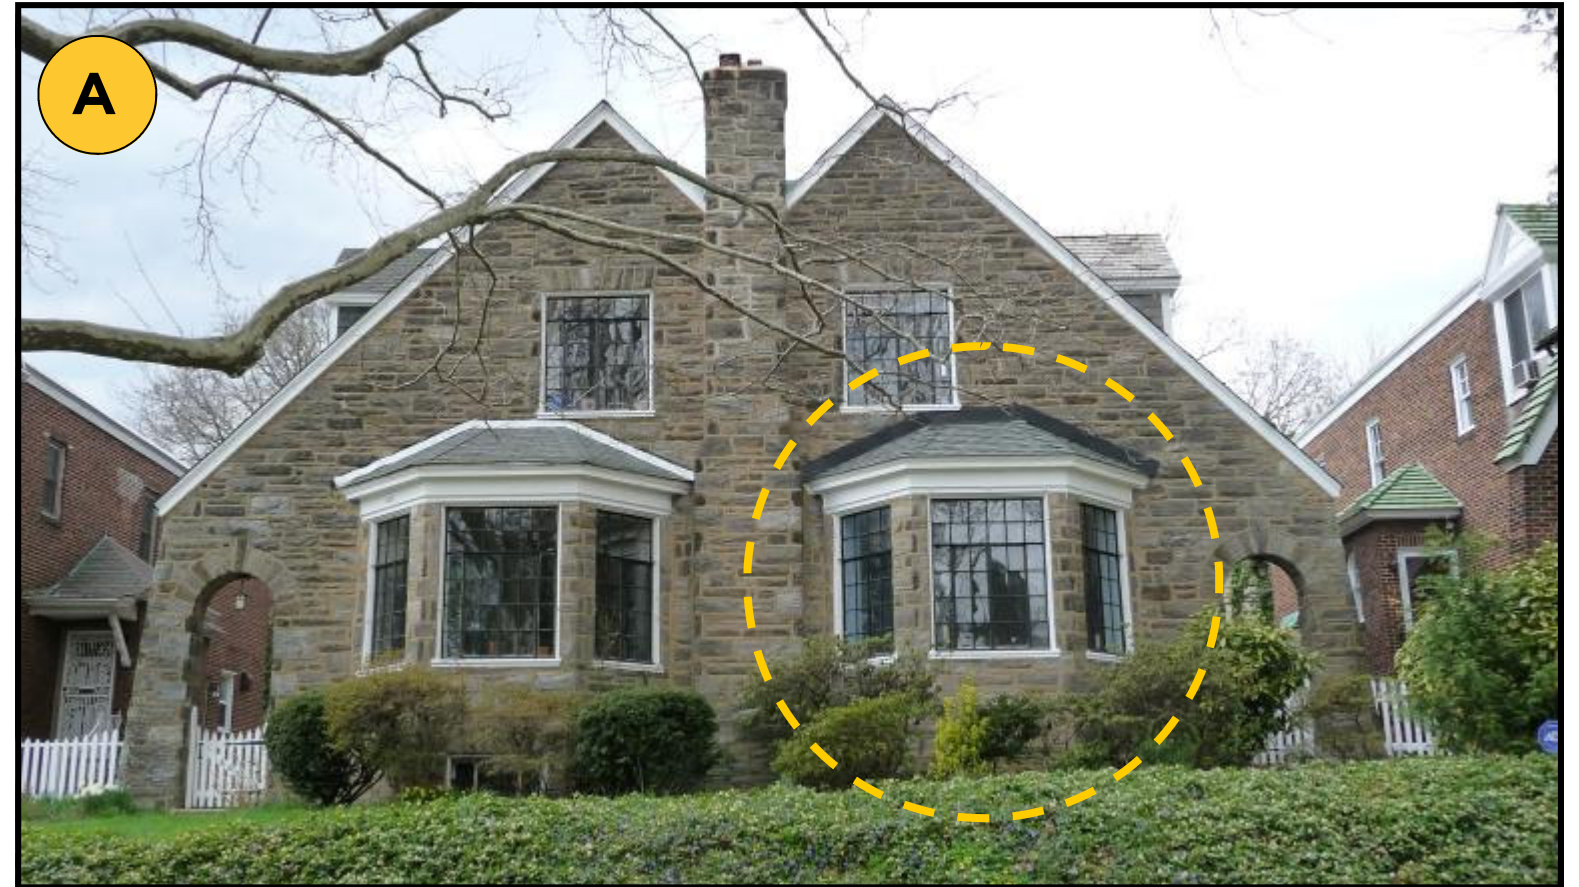
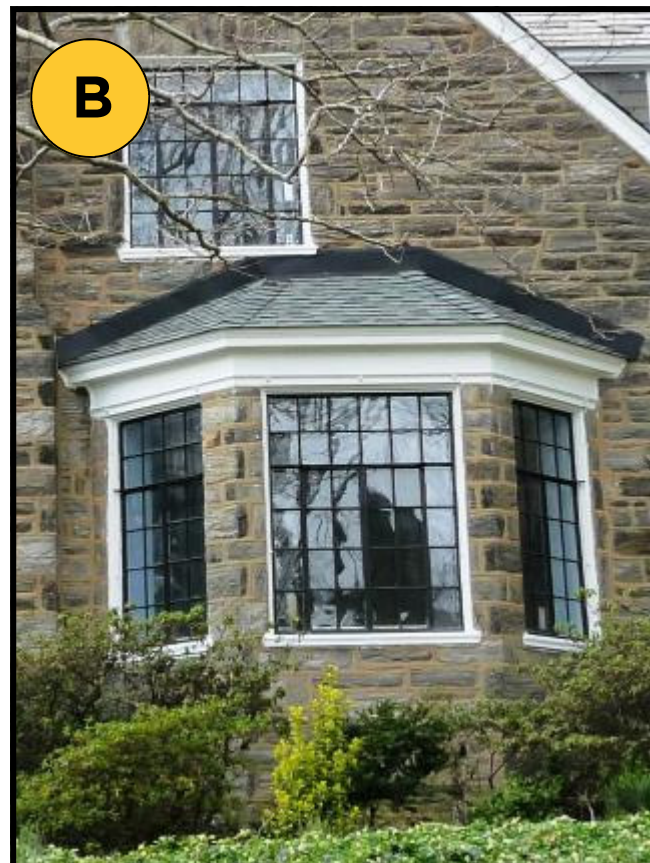
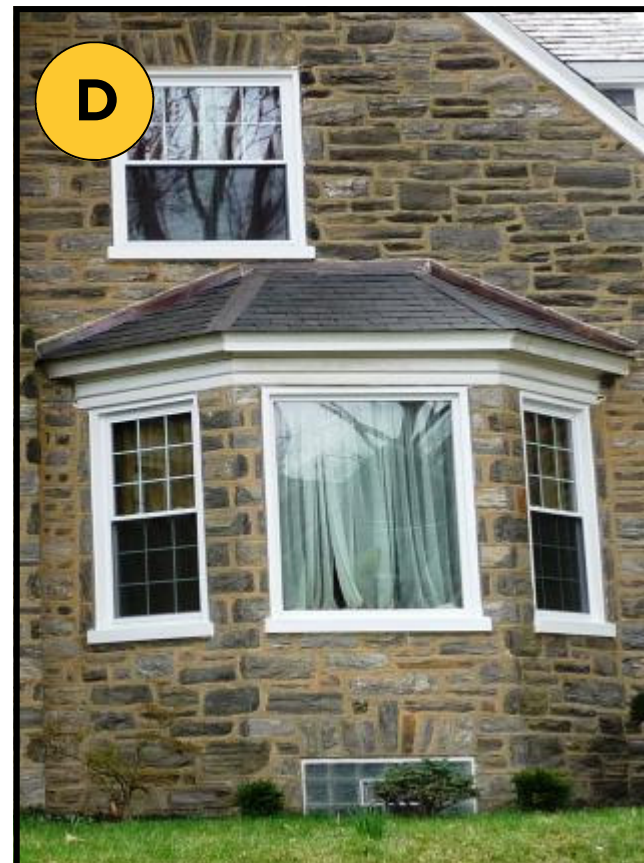
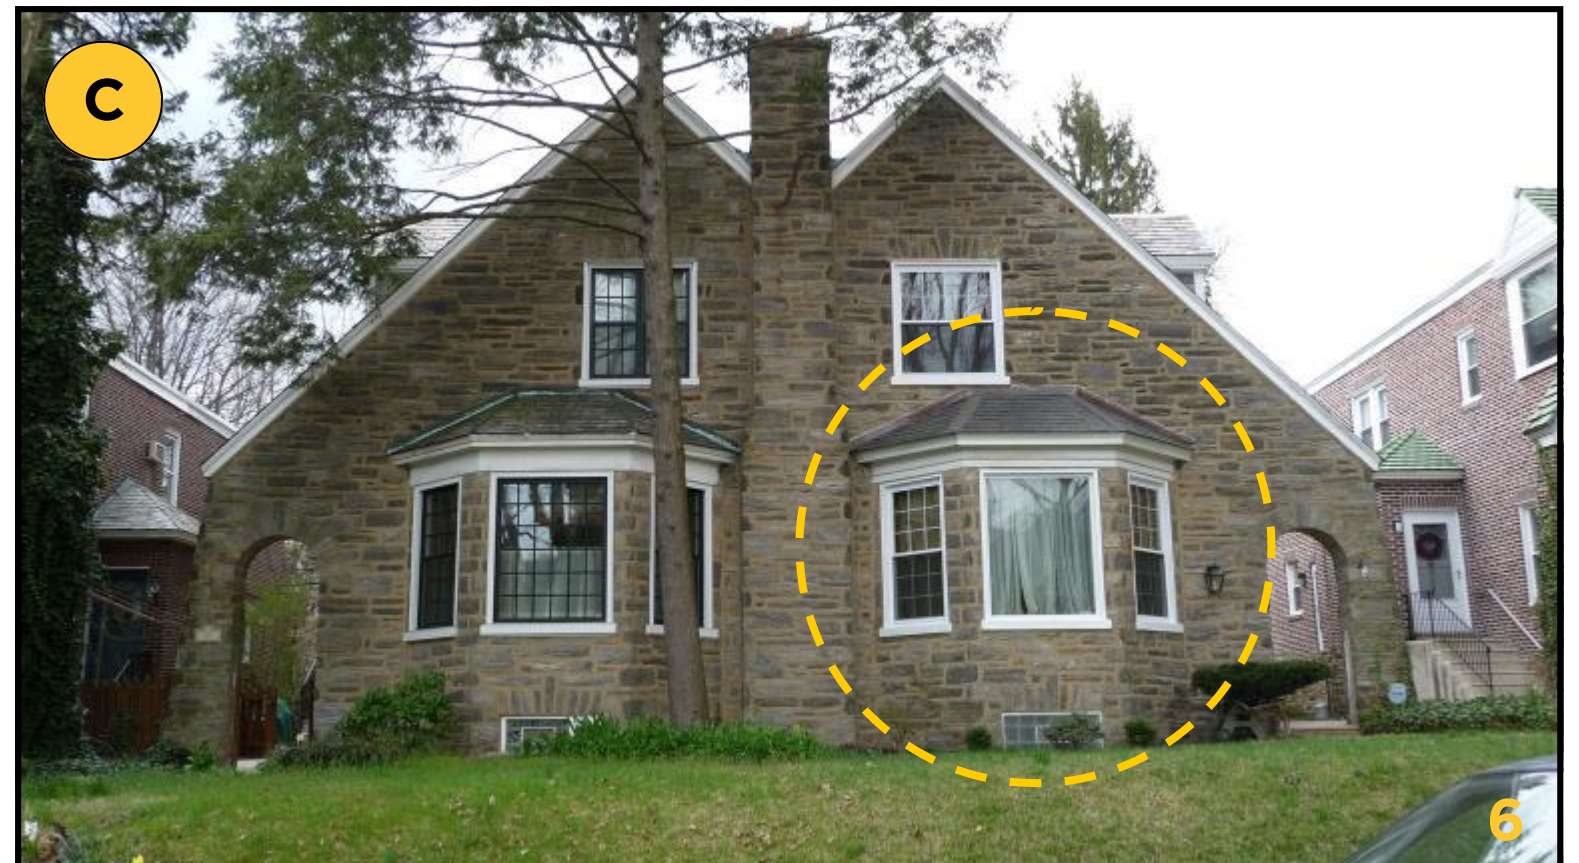
- A, B Both sides of this duplex feature original rolled steel casement windows with interior storm window inserts.
- C, D Both sides of this duplex have replacement windows. The one to the left more closely mimics the lines and details of the original steel casements, though the new windows are a mixture of fixed and double-hung sash units and the proportions are not an exact match. The unit to the right also features fixed and double-hung sash replacement windows. In this case, the result is less successful with white vinyl casing and a central picture window missing any muntin pattern.

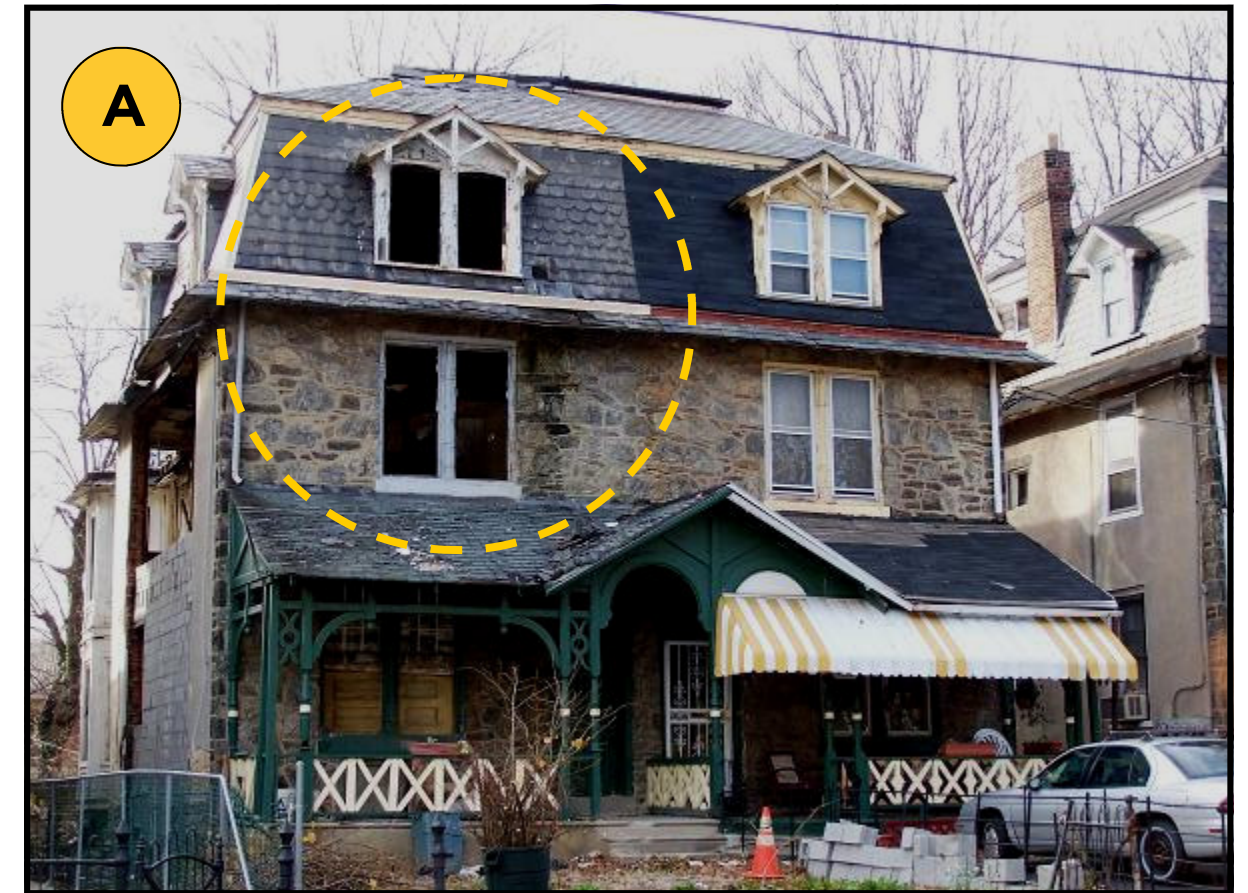
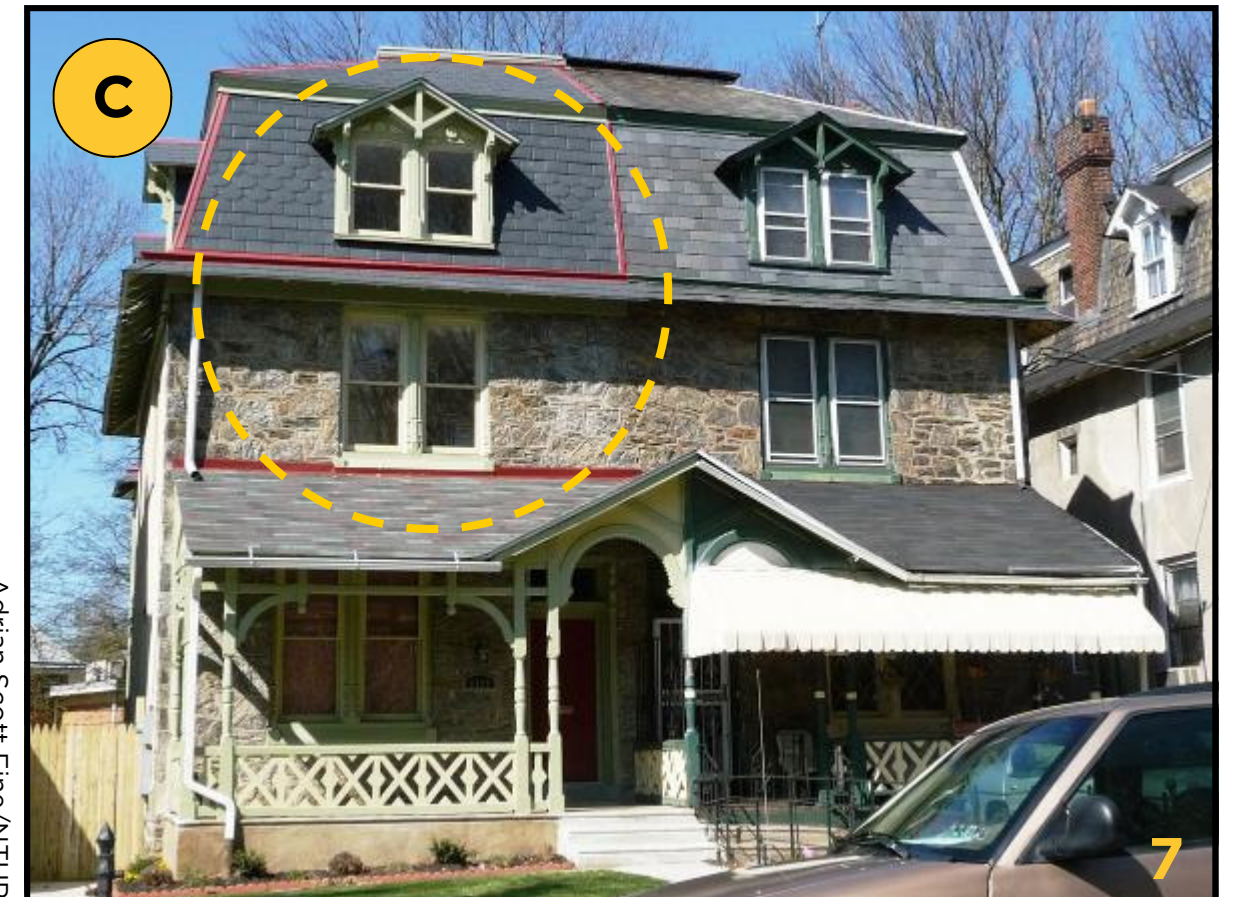
- A, B Original windows are missing but decorative casings and openings remain.  
C, D As part of the rehabilitation project, new wood double-hung sash windows were chosen to fit the original openings and the decorative casings were repaired and retained. New windows replicate the originals in terms of size, type, proportion and materials.

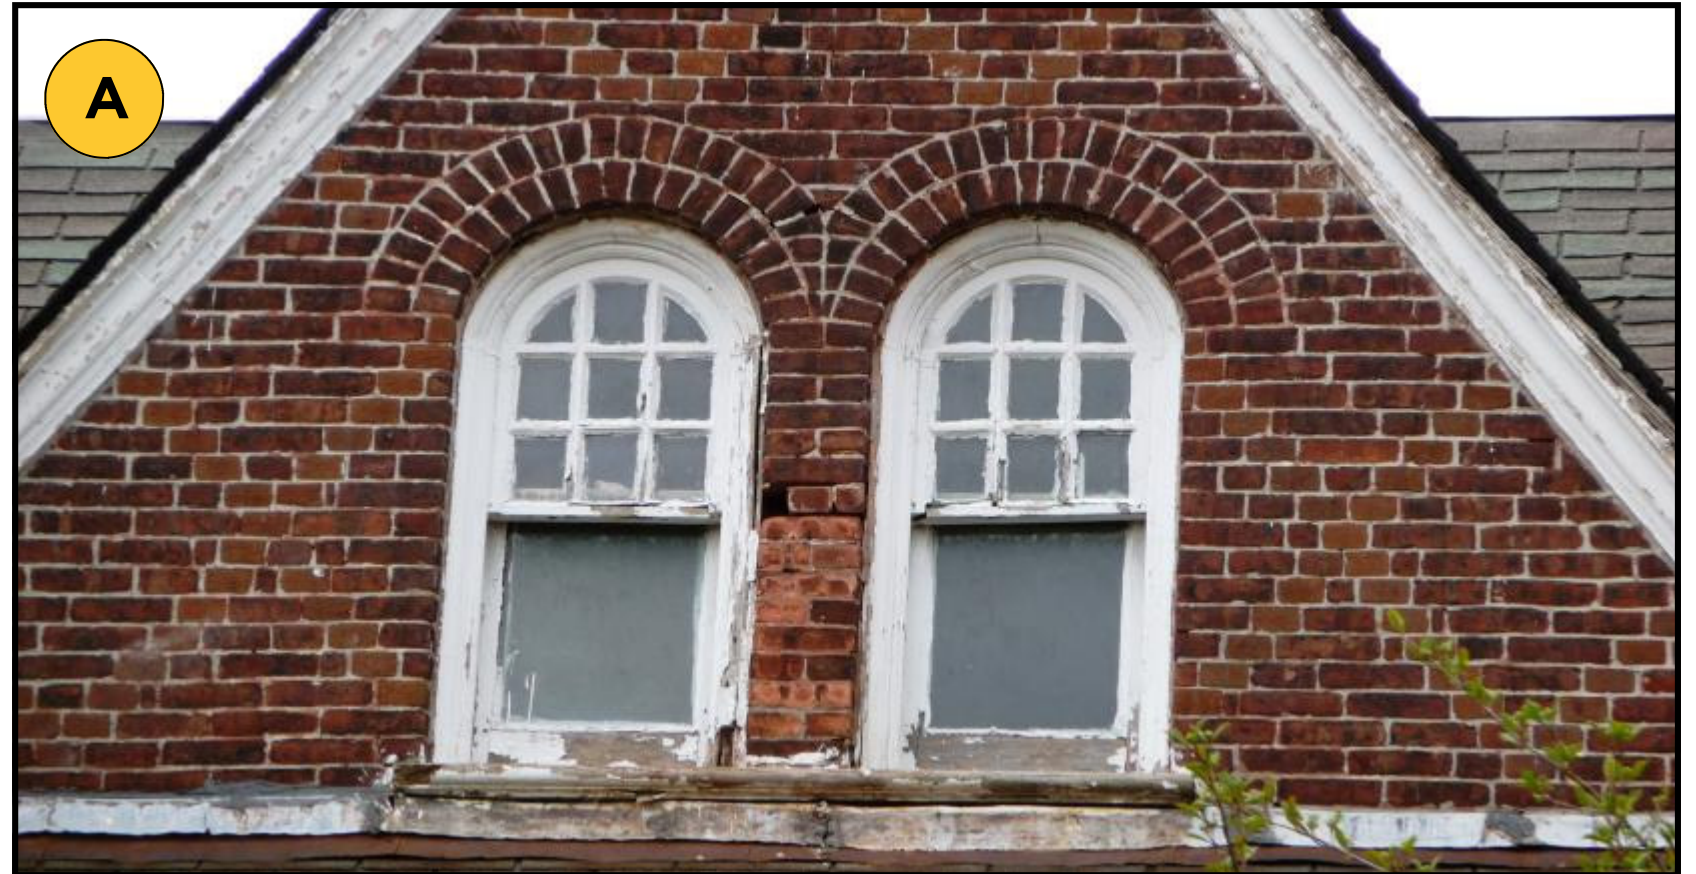
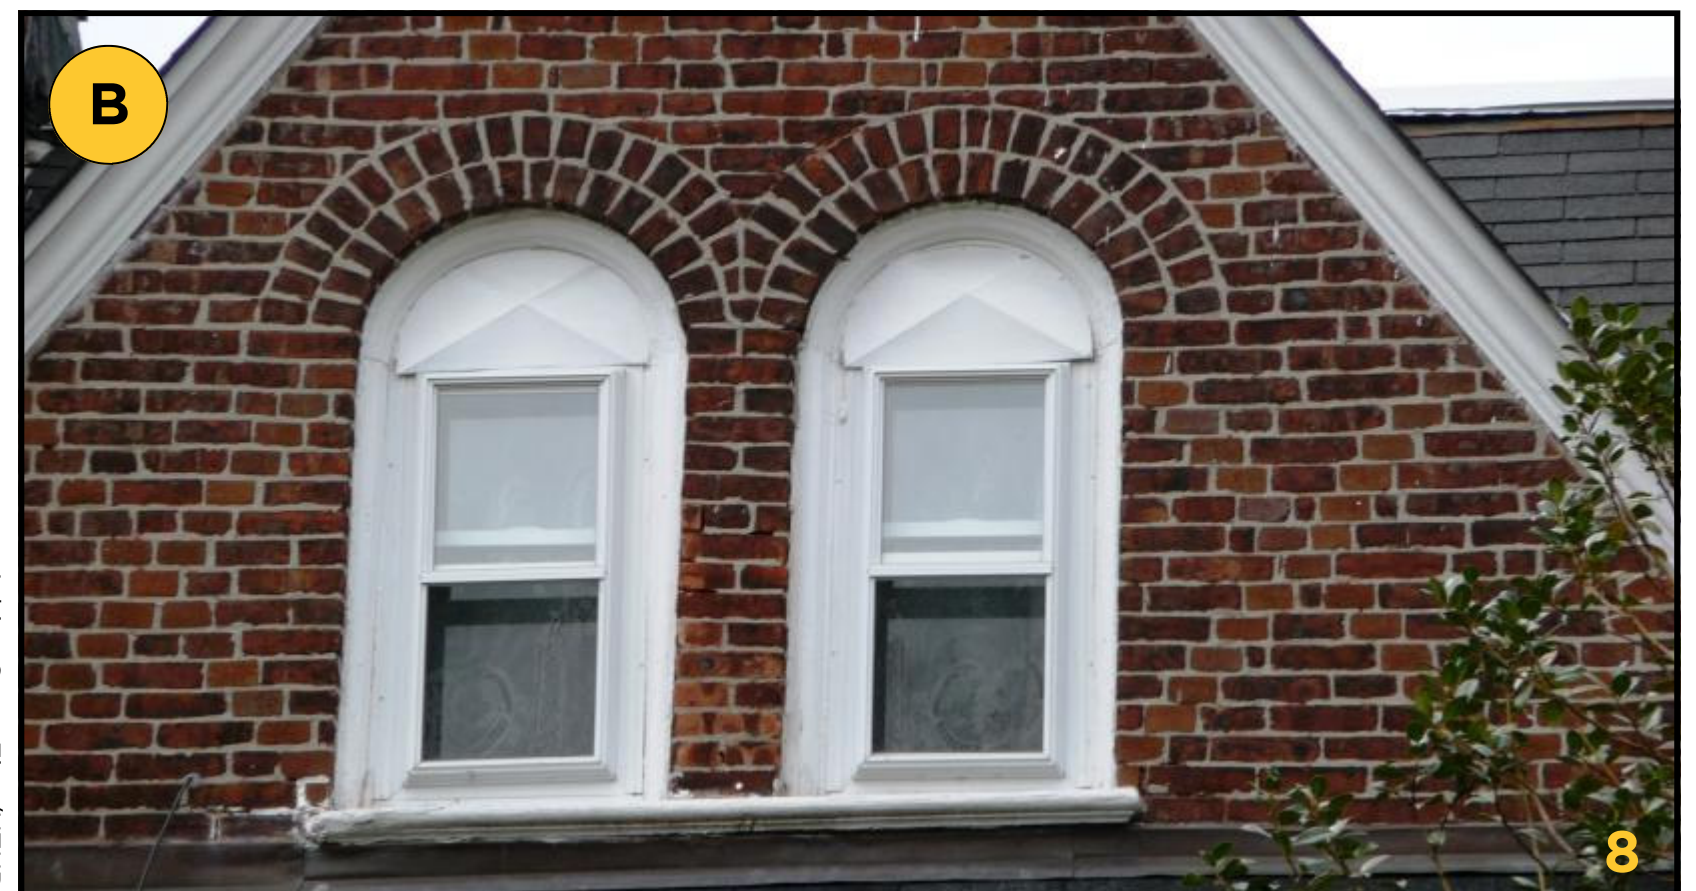
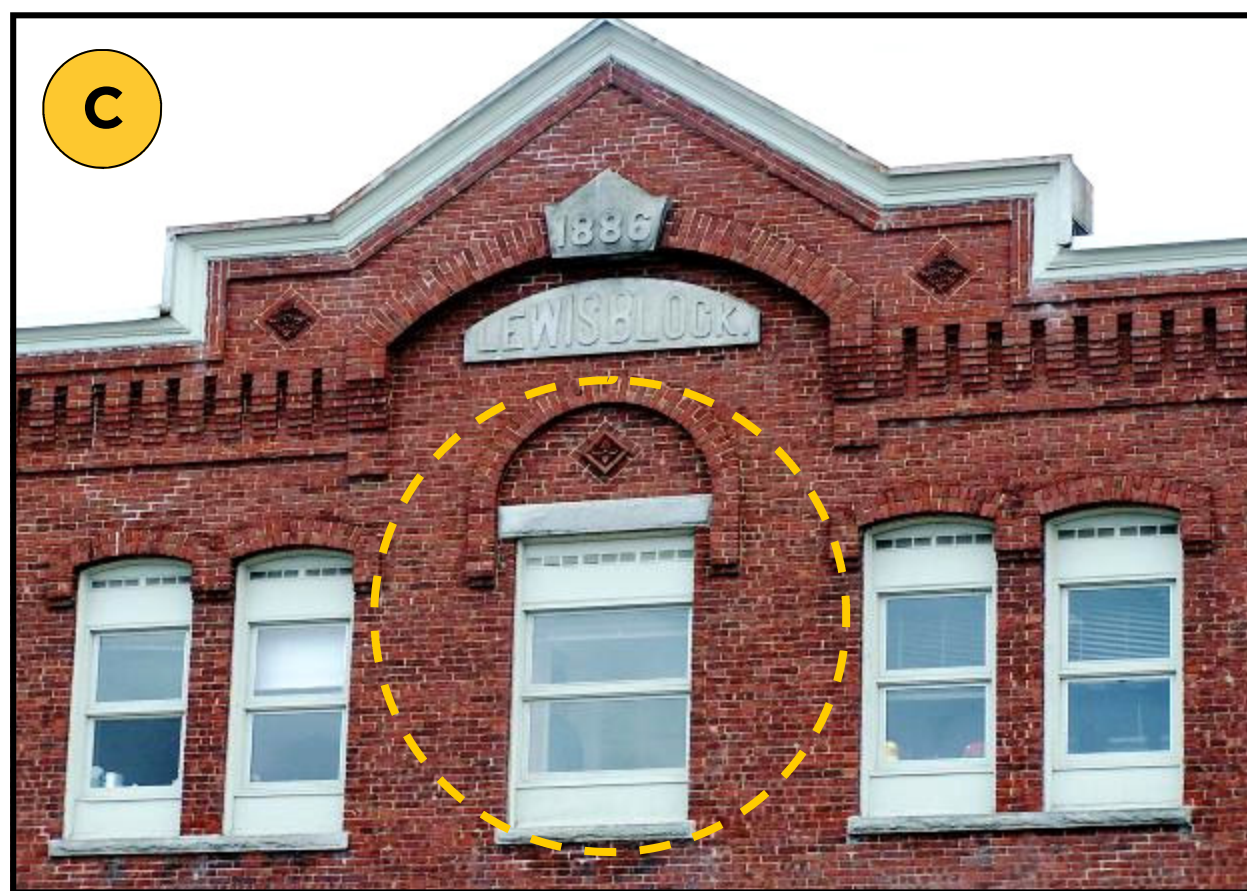
- A Two, arched nine-over-one double-hung sash windows are in disrepair with loose meeting rails and paint build up. They can be easily repaired and still maintain the character of the building.
- B An identical building with replacement windows. Stock units were used with aluminum in-fill around the opening. The difference in character between A and B is dramatic.
- C The upper story windows of this Main Street commercial structure were replaced with stock units with in-fill at the top and bottom.
