NATIONAL  
TRUST  
FOR  
HISTORIC  
PRESERVATION®

# Repair or Replace Old Windows

**A Visual Look at the Impacts**

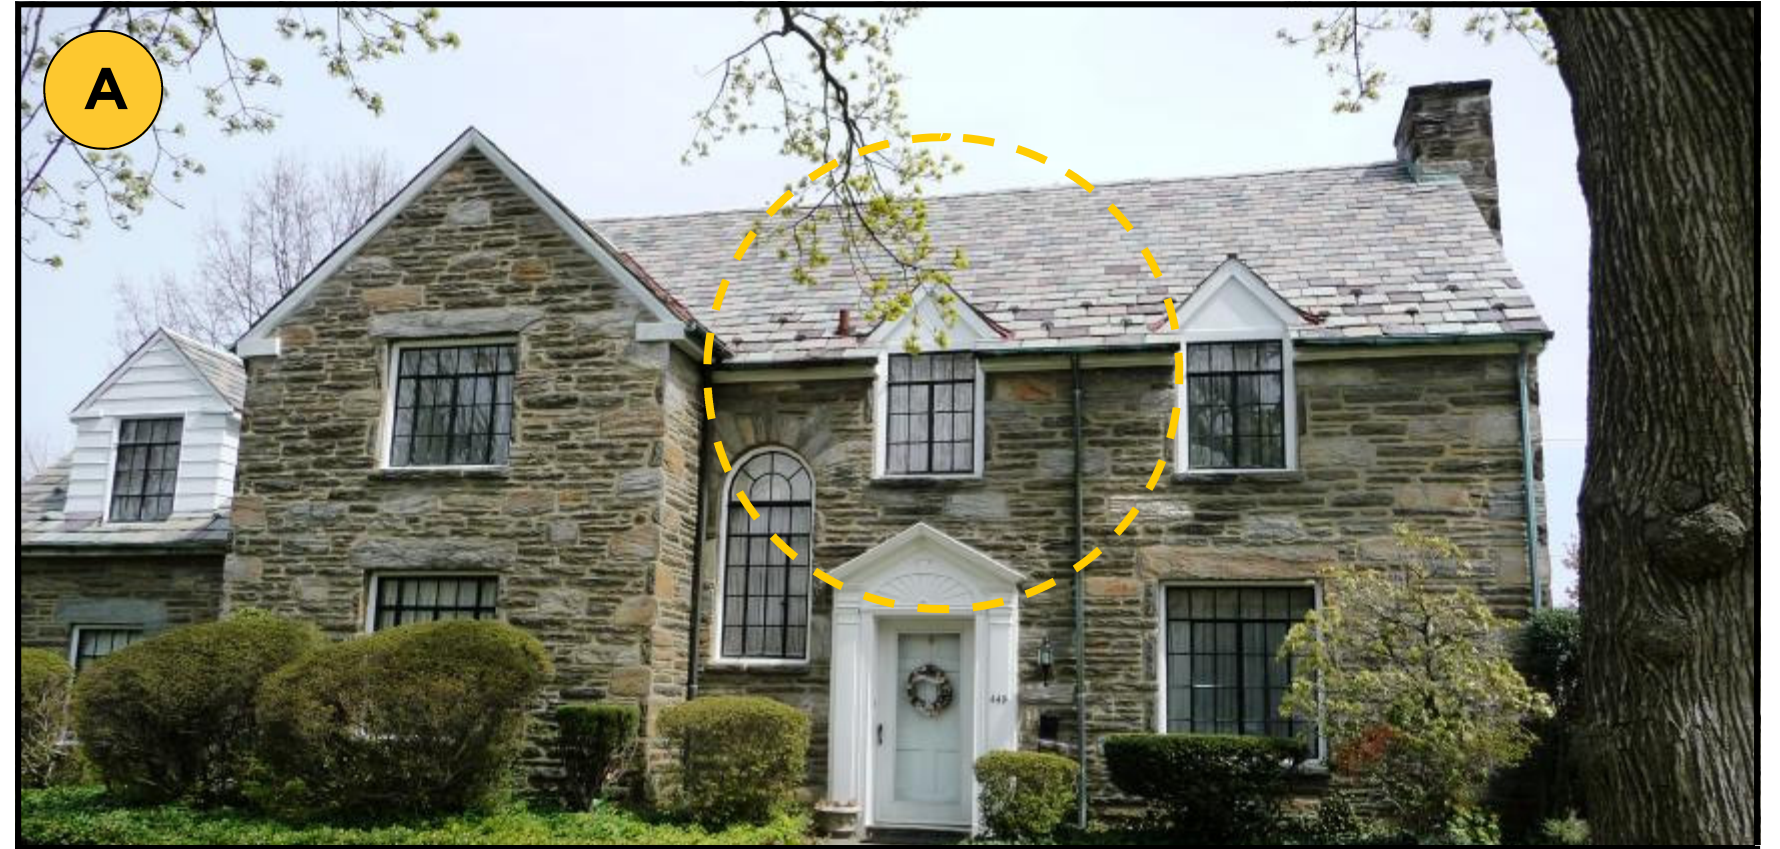
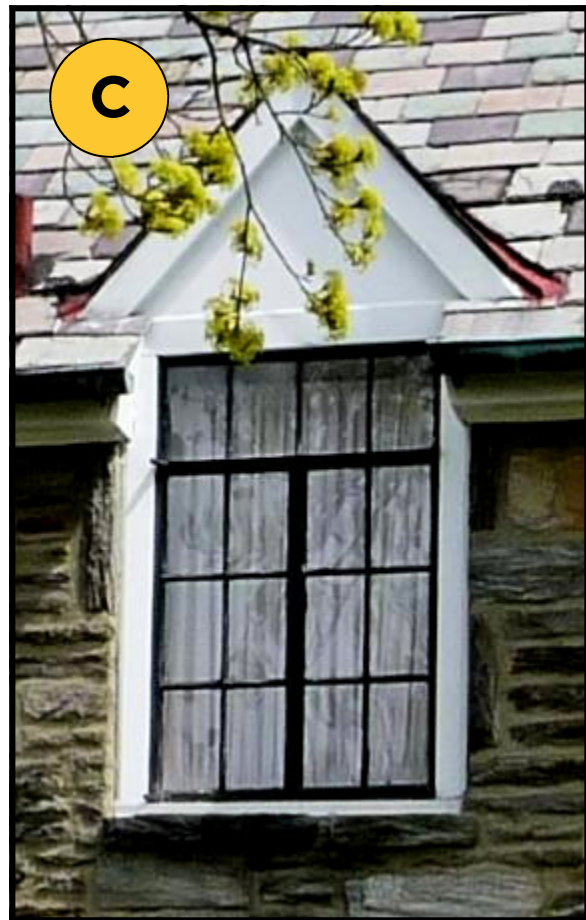
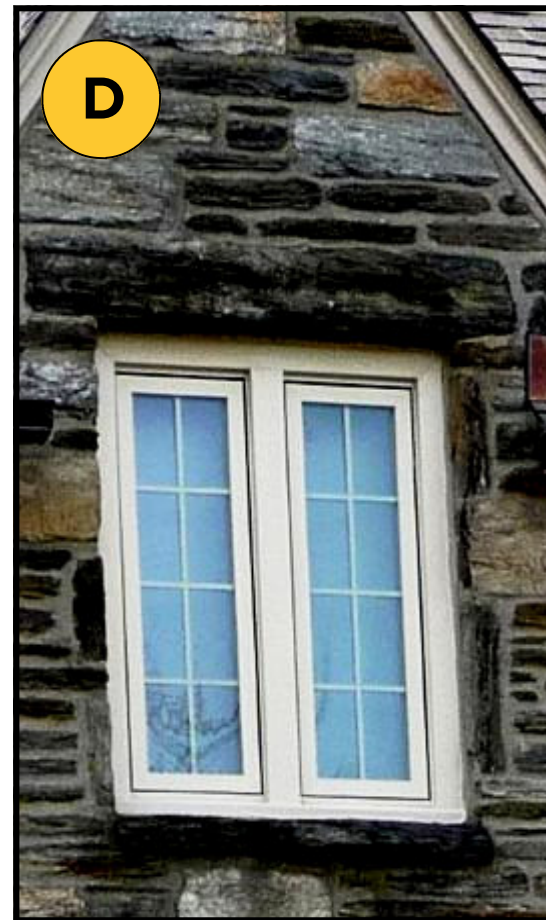
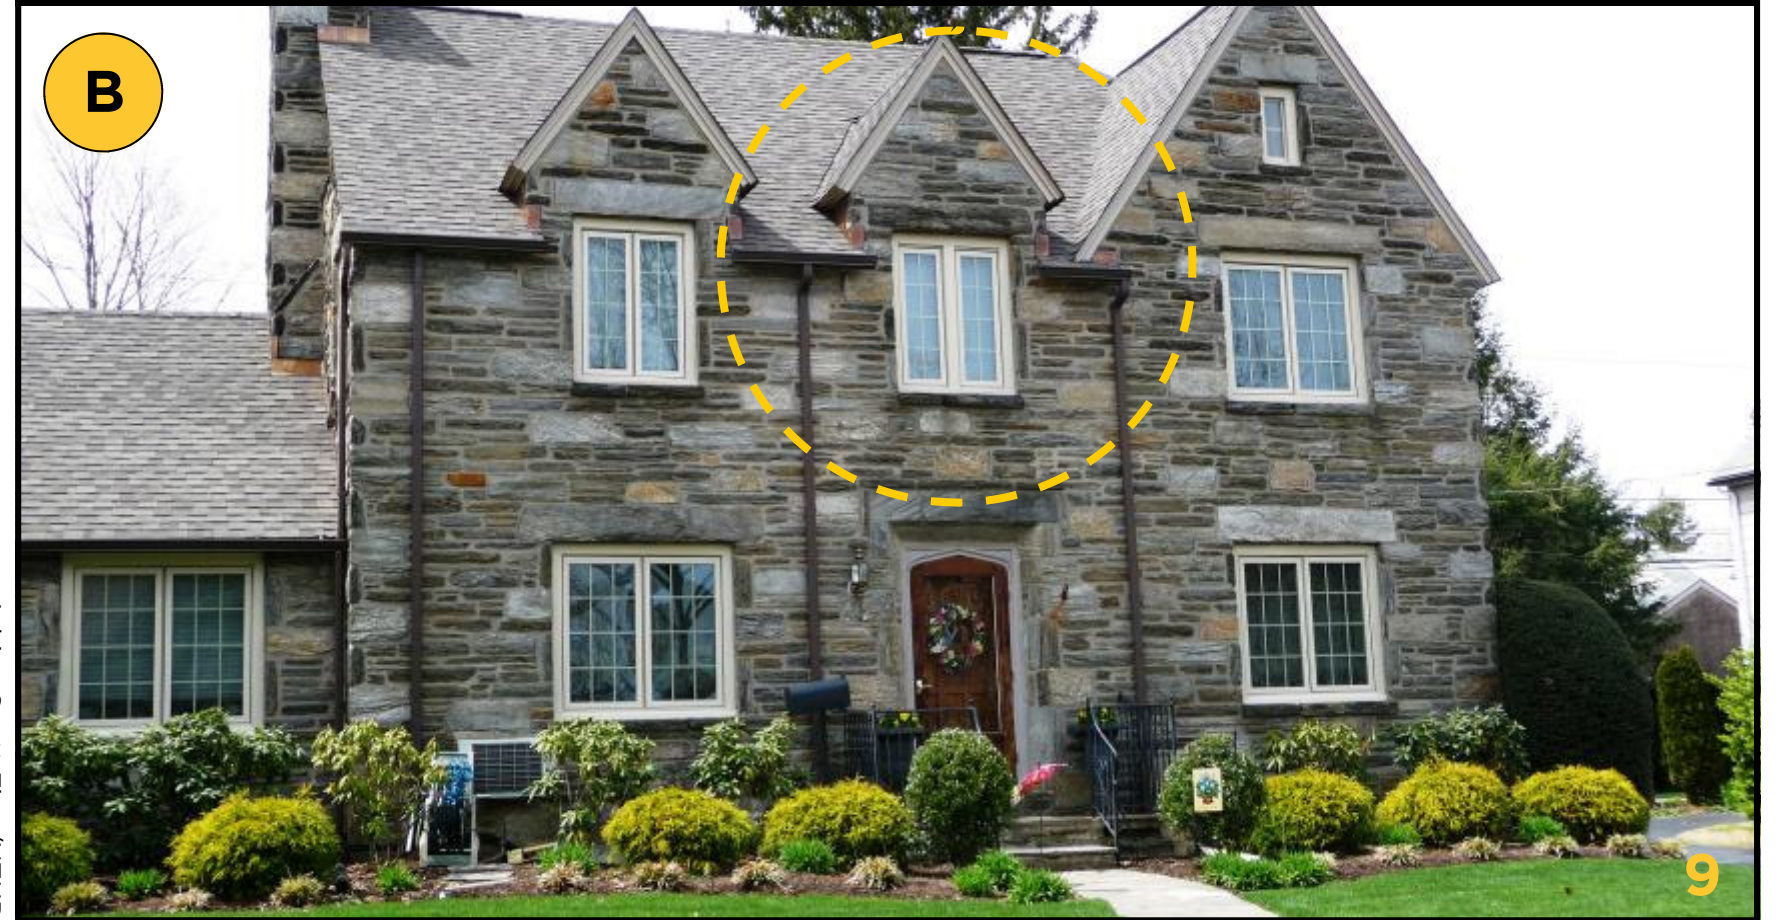
- A Steel casement windows with fixed transoms and side-lights, featuring interior storm windows. These windows are a character defining feature of the house.
- B Replacement windows attempt to match with casement style units yet the proportion, pattern, width and lack of a true divided-light miss the mark.
- C, D The differences between the original and replacement are readily seen, where the wider casing and surround are much prominent on the replacement windows.

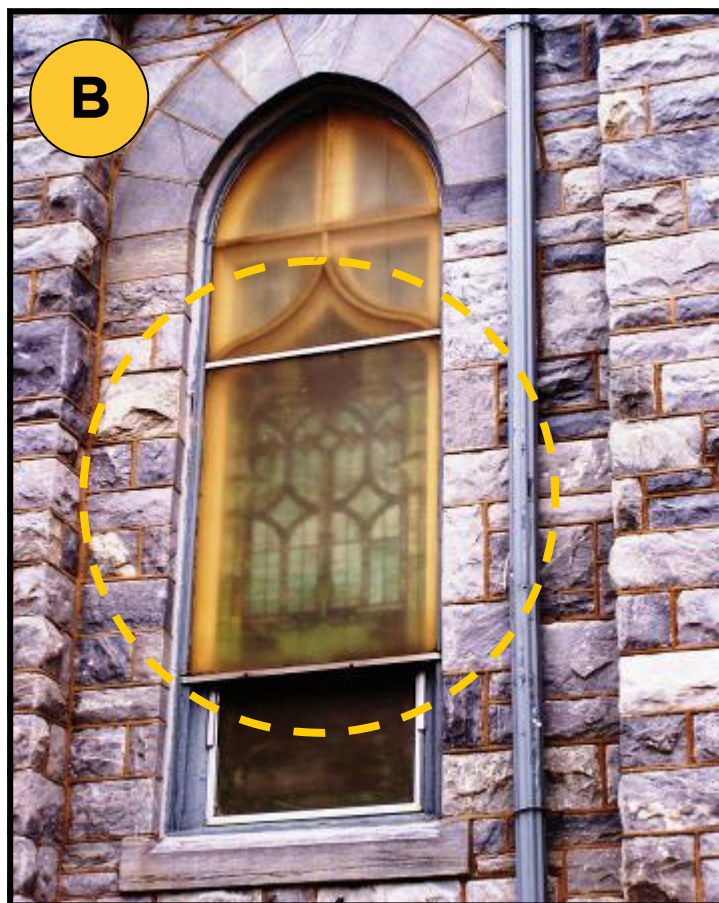
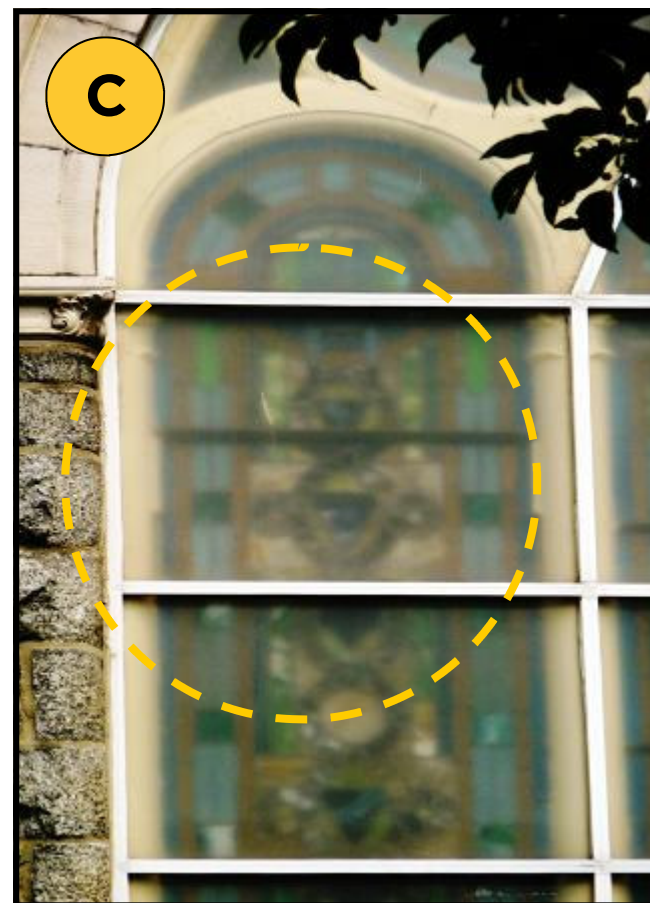
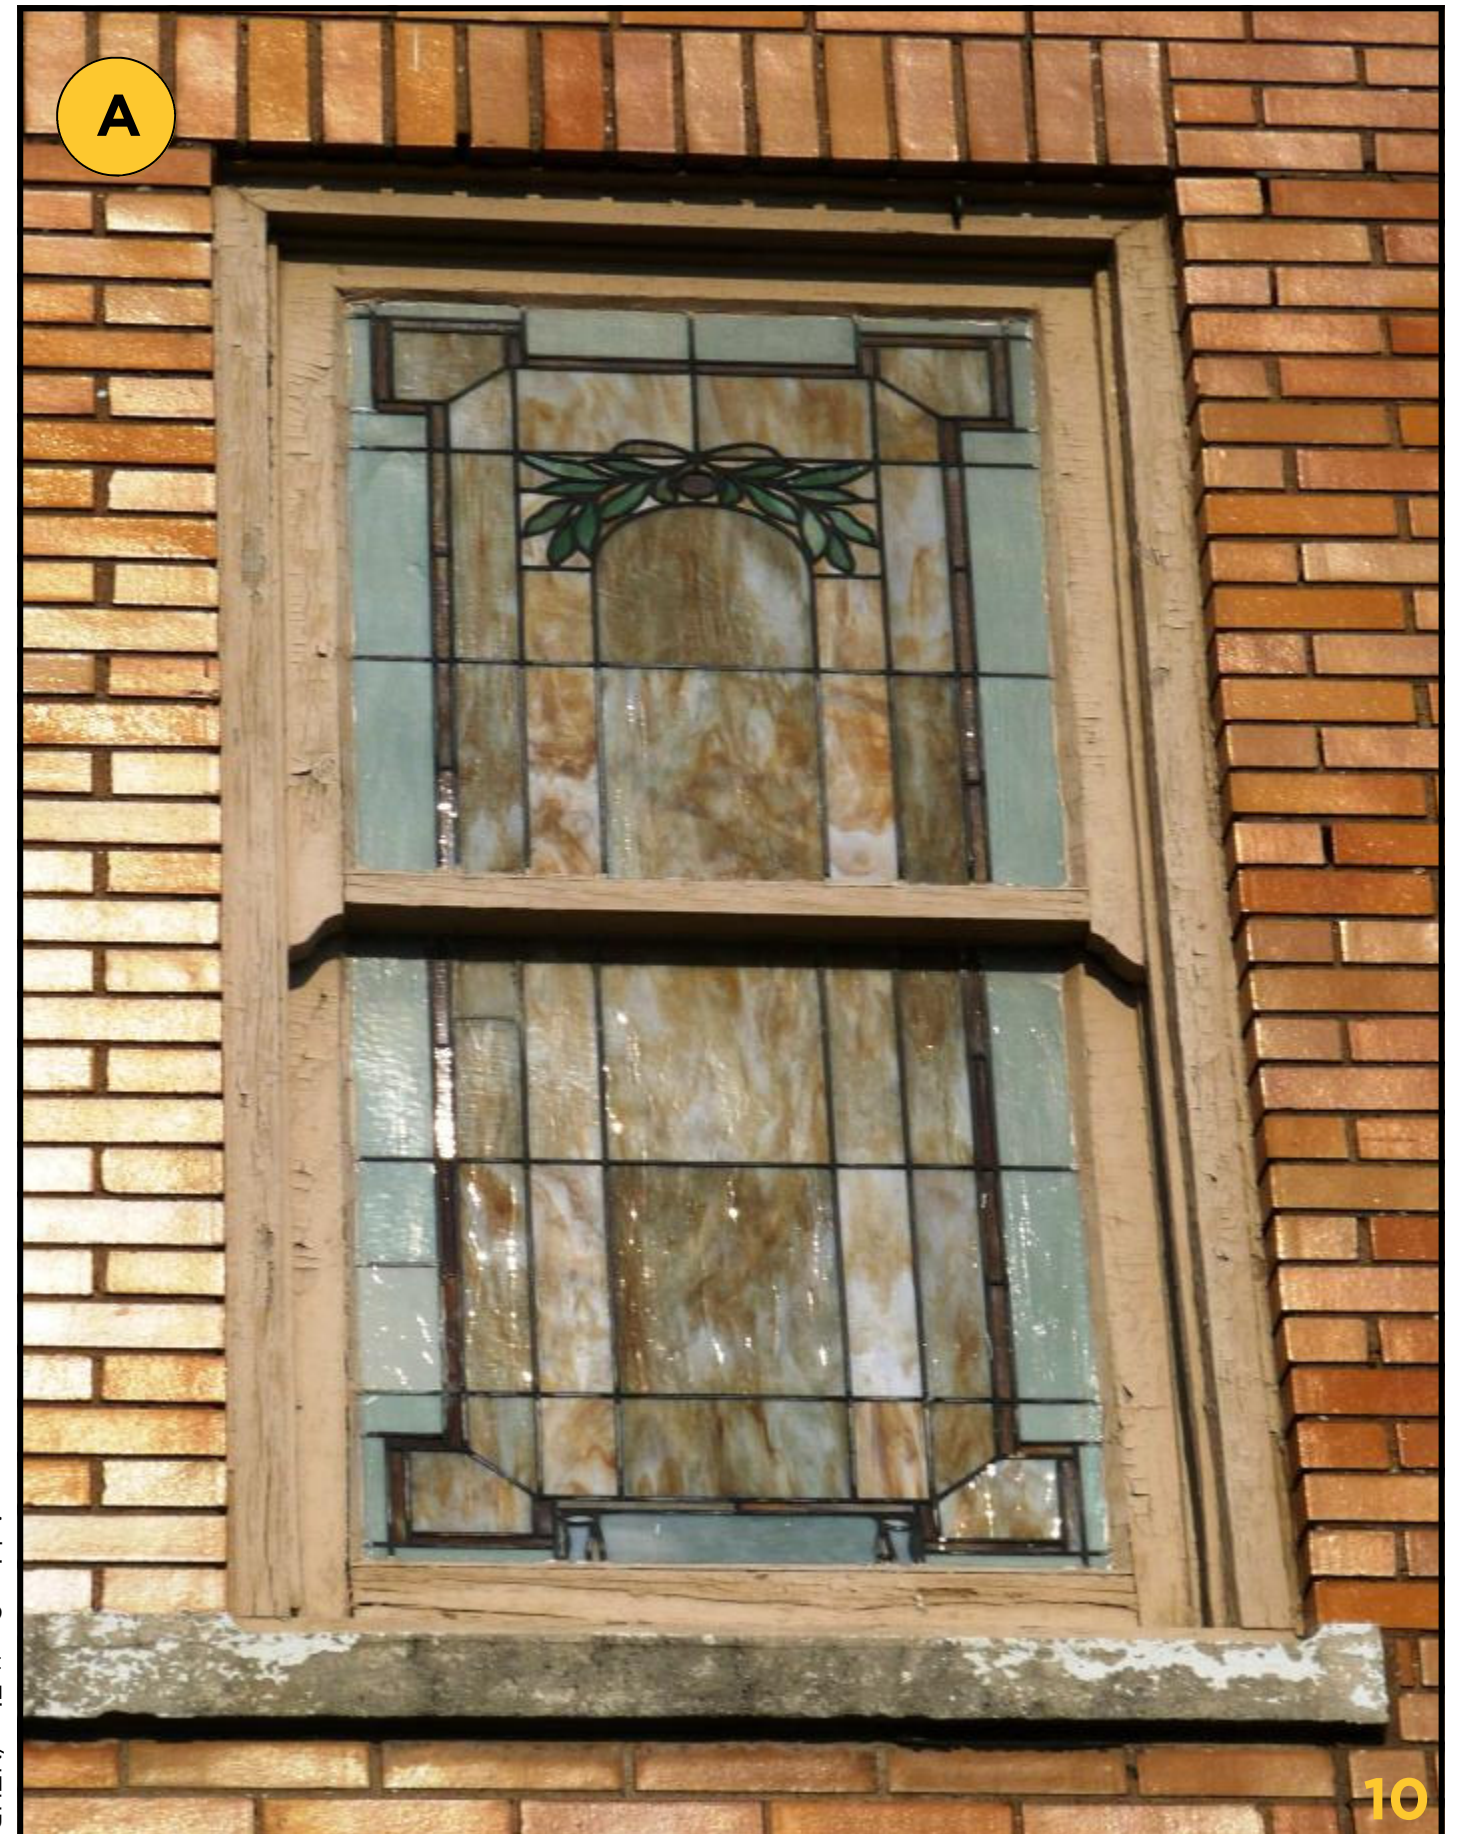
- A Exposed original one-over-one double-hung slag glass window .
- B Plastics (Lexan or Plexiglass) are impact-resistant and nearly shatter-proof but tend to yellow and get hazy over time.
- C Windows are obscured and the pattern is dramatically altered with new aluminum rails as part of this protective glazing system.

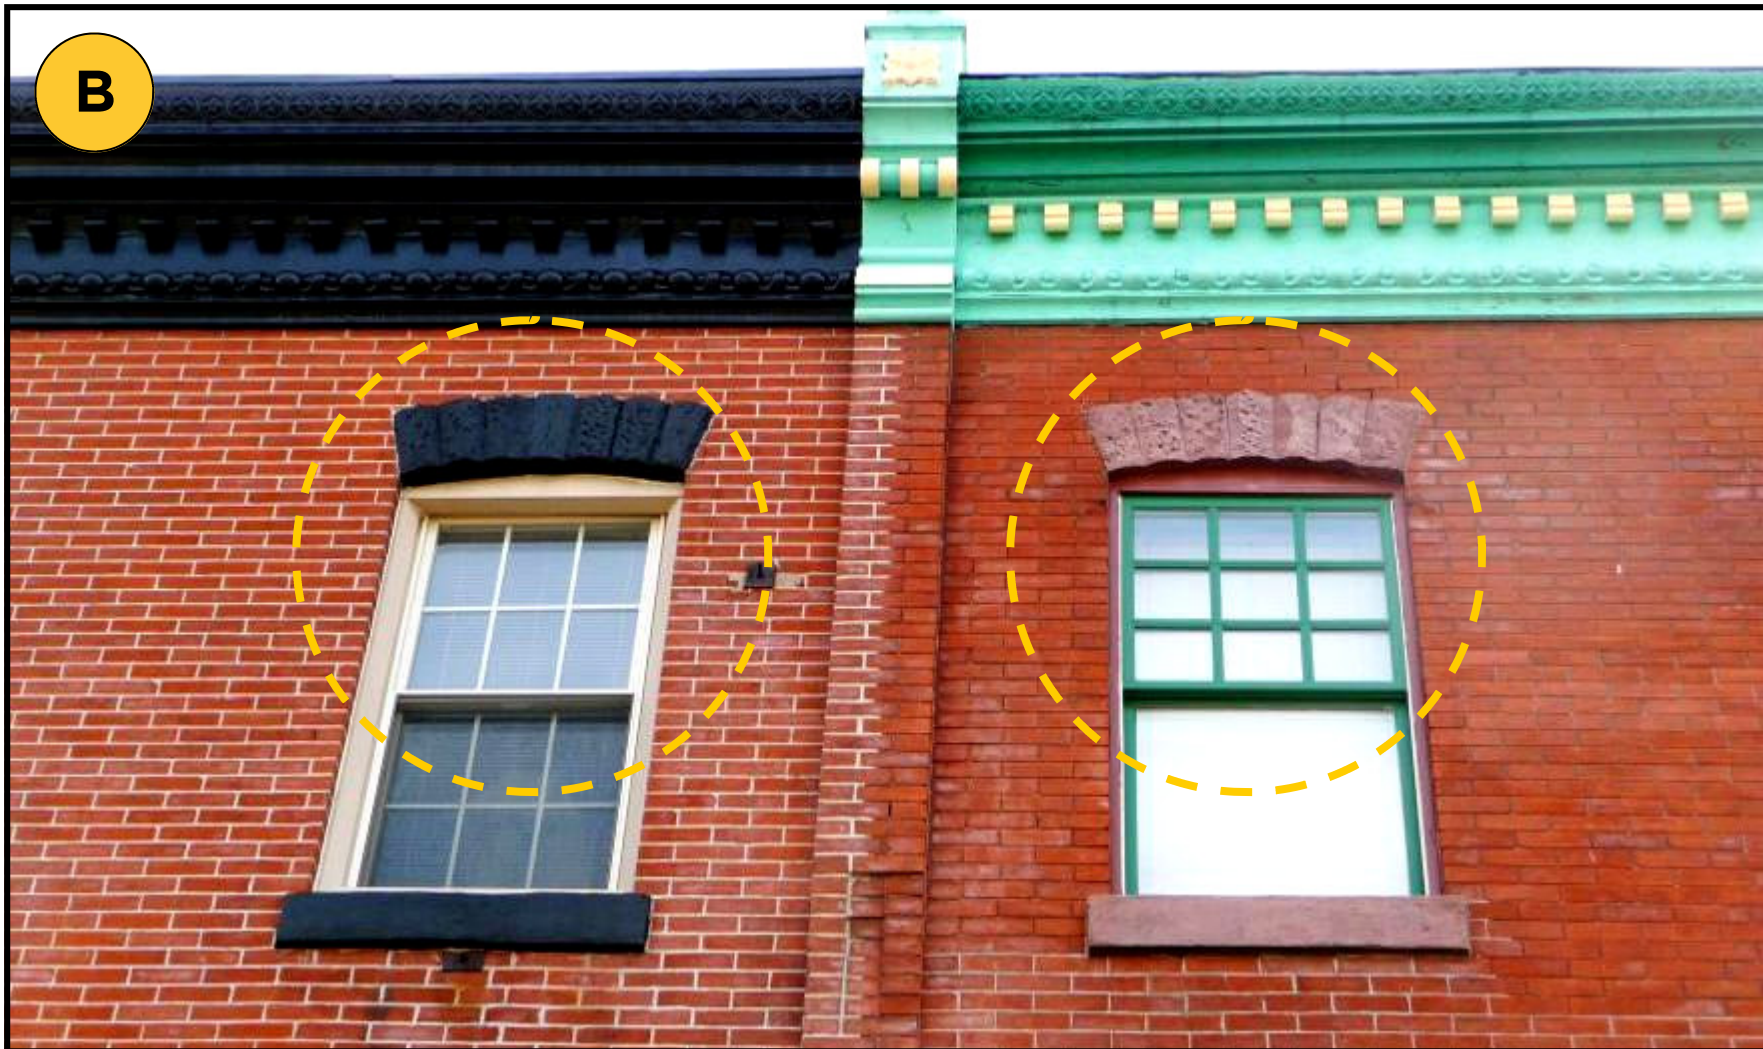
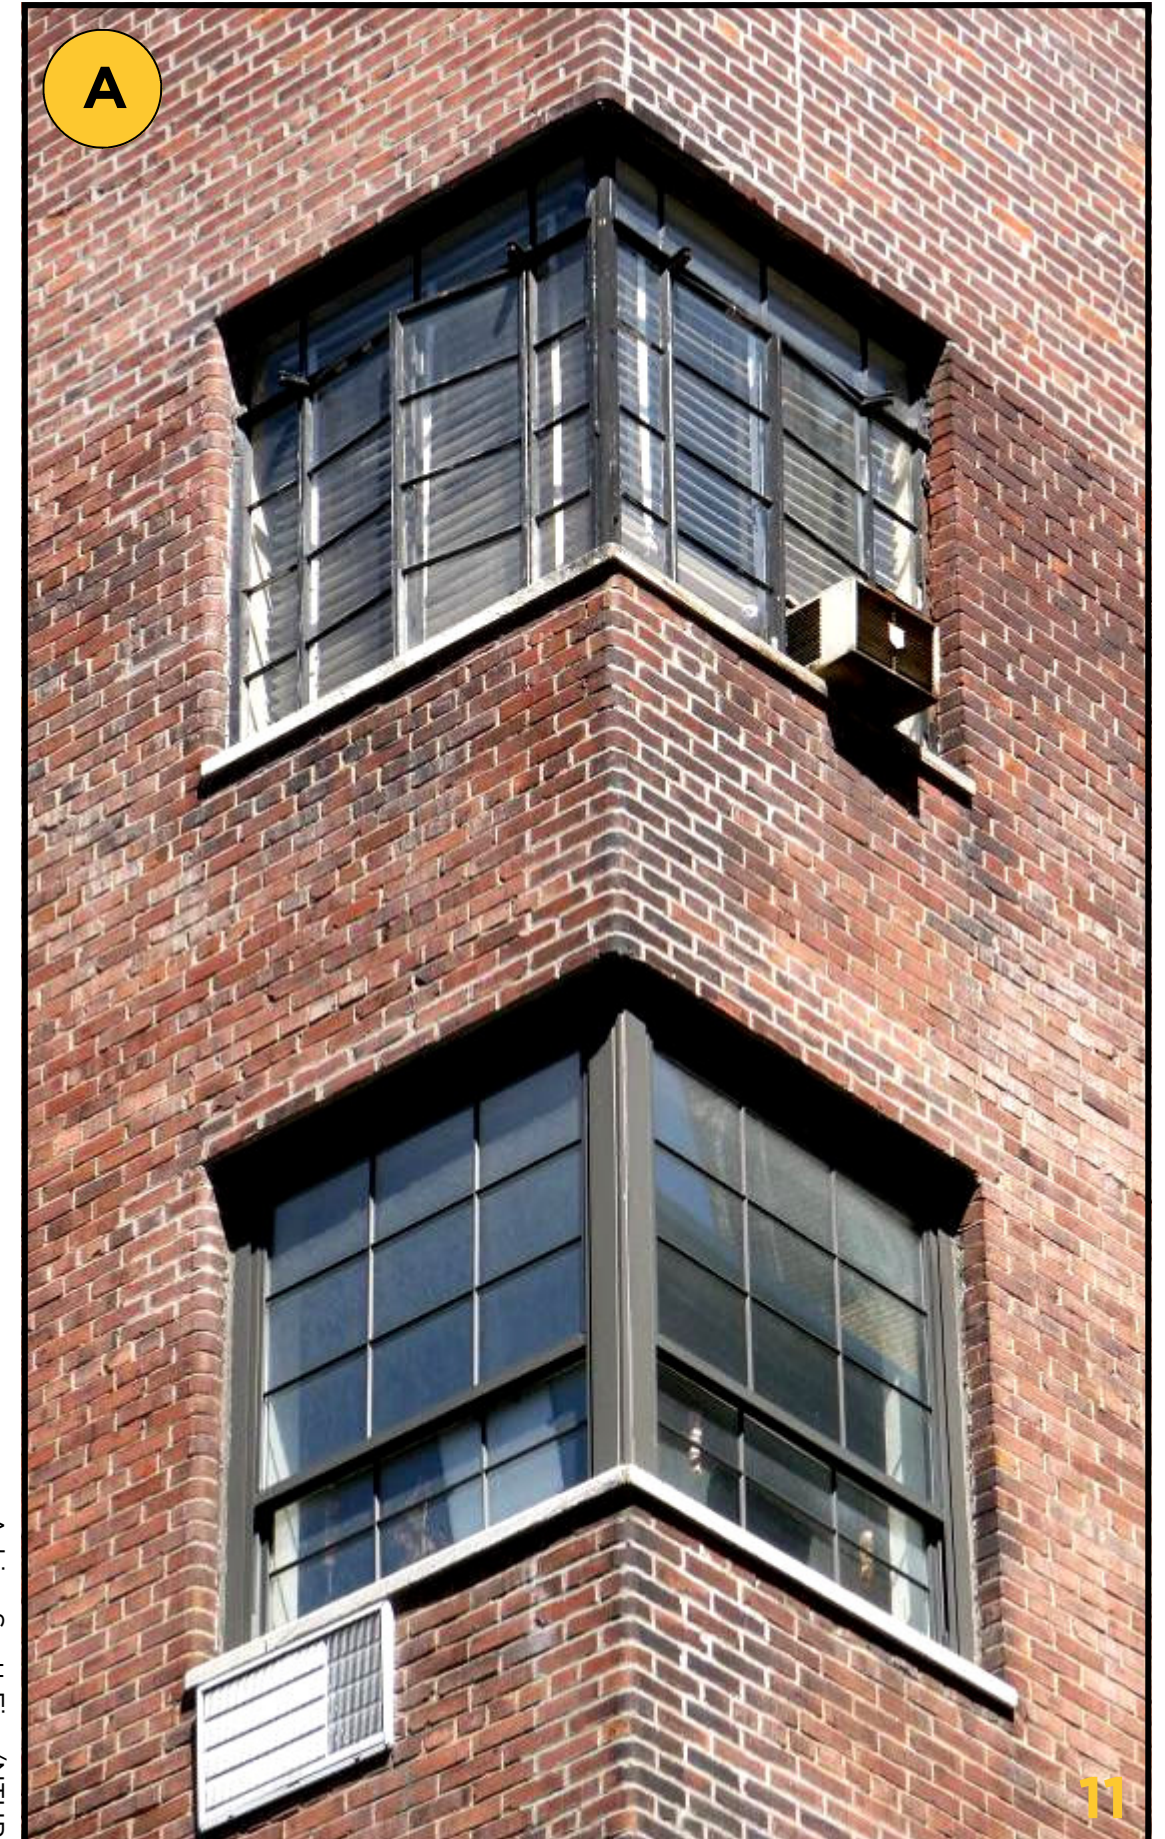
- A An early 1940s apartment building designed in the Art Deco style features corner, steel casement windows. The slender profile of the muntins and casing is a character defining feature. The replacement double-hung sash window, at the bottom, attempts to match the lines of the original, yet the muntin pattern and width of casing are much different.
- B Two double-hung sash replacement windows on side-by-side row houses demonstrate the subtle, but noticeable differences in design. While original windows were identical, these are different in terms of depth, muntin size and pattern and width of casing.

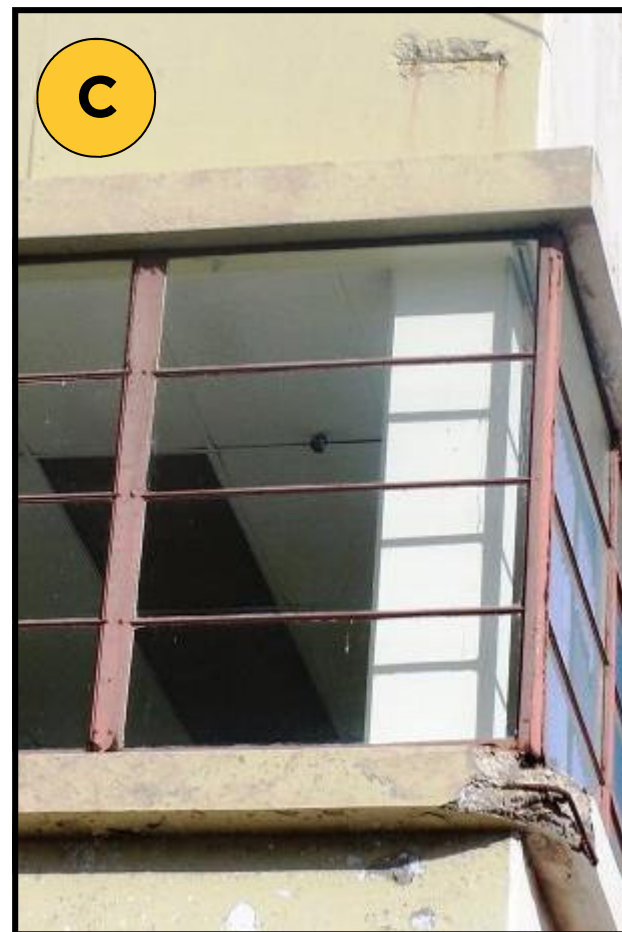
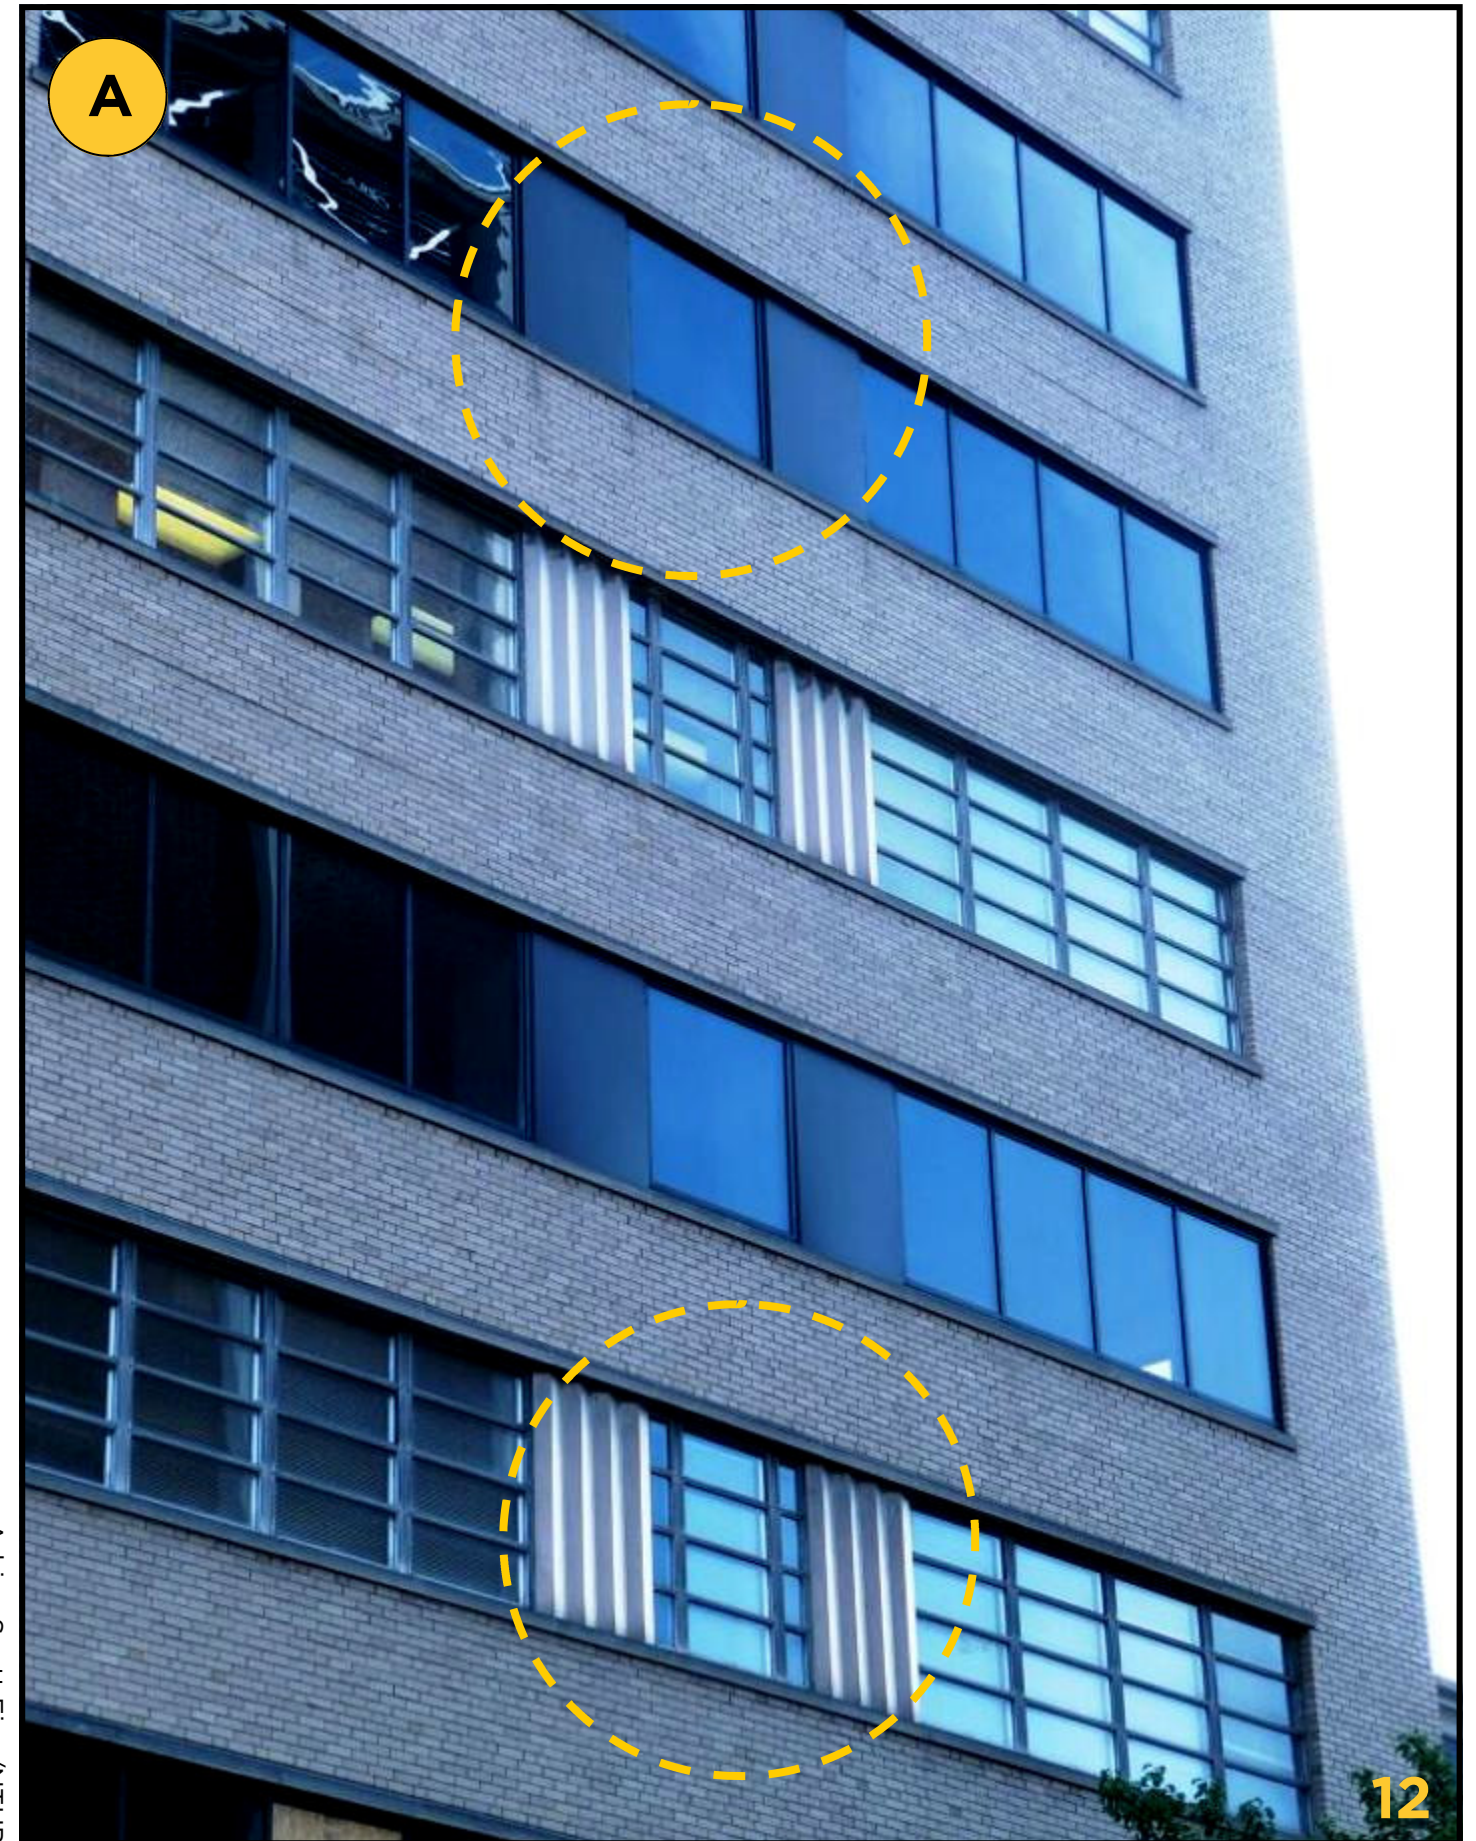
- A Original, character defining windows and corrugated stainless steel detail are being removed on this 1950s office building, replaced by dark tinted fixed windows that do not match.
- B, C Large spans of single pane and plate glass require innovative solutions, such as custom designed storm windows.

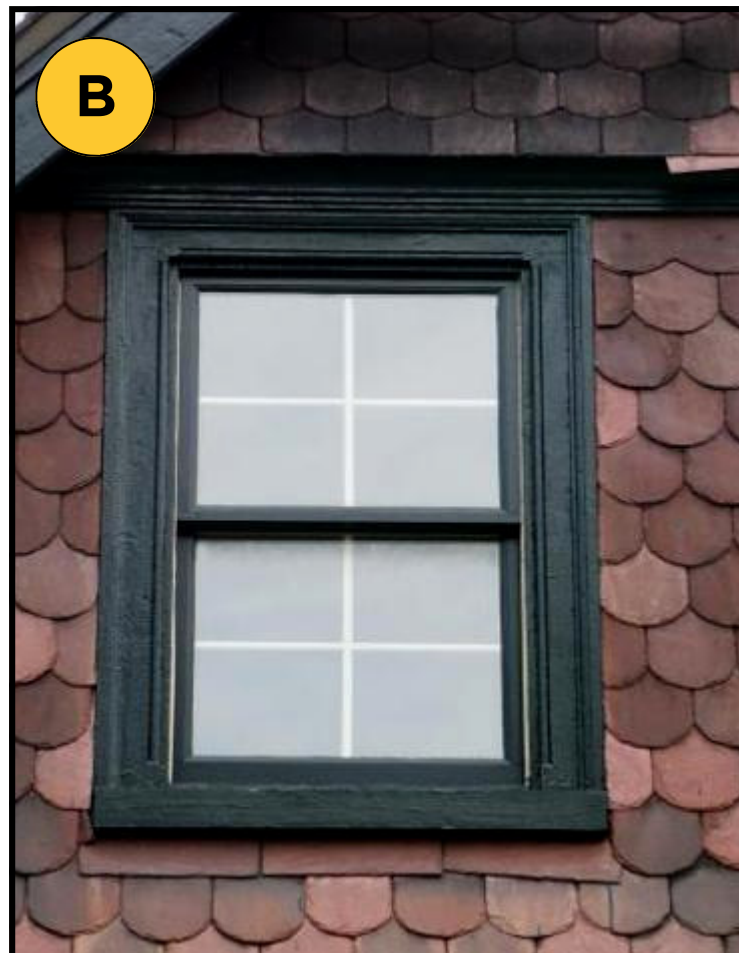
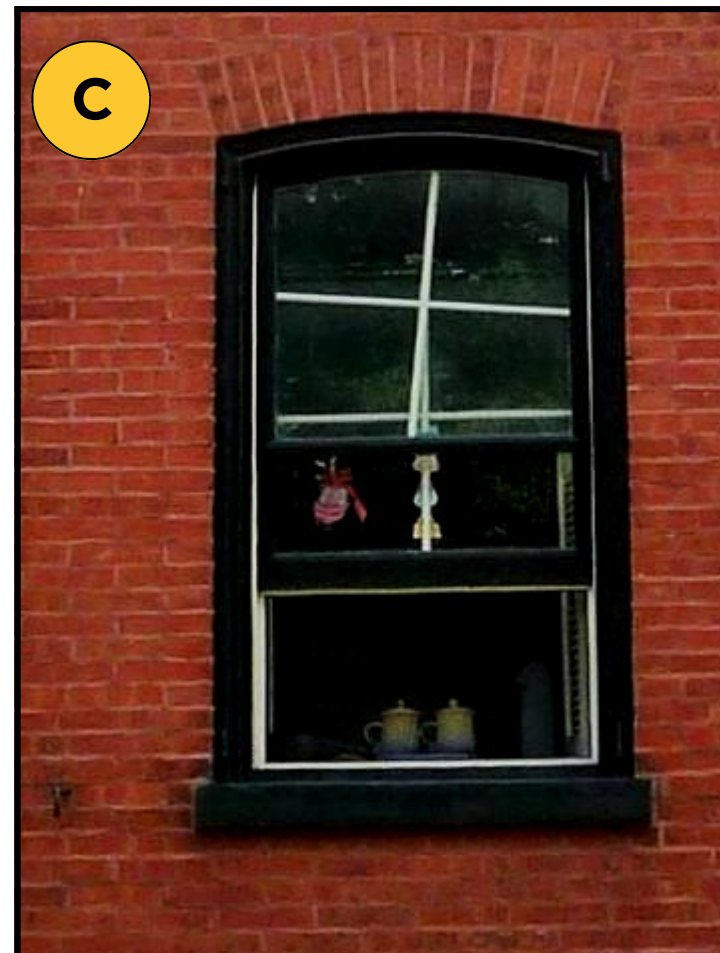
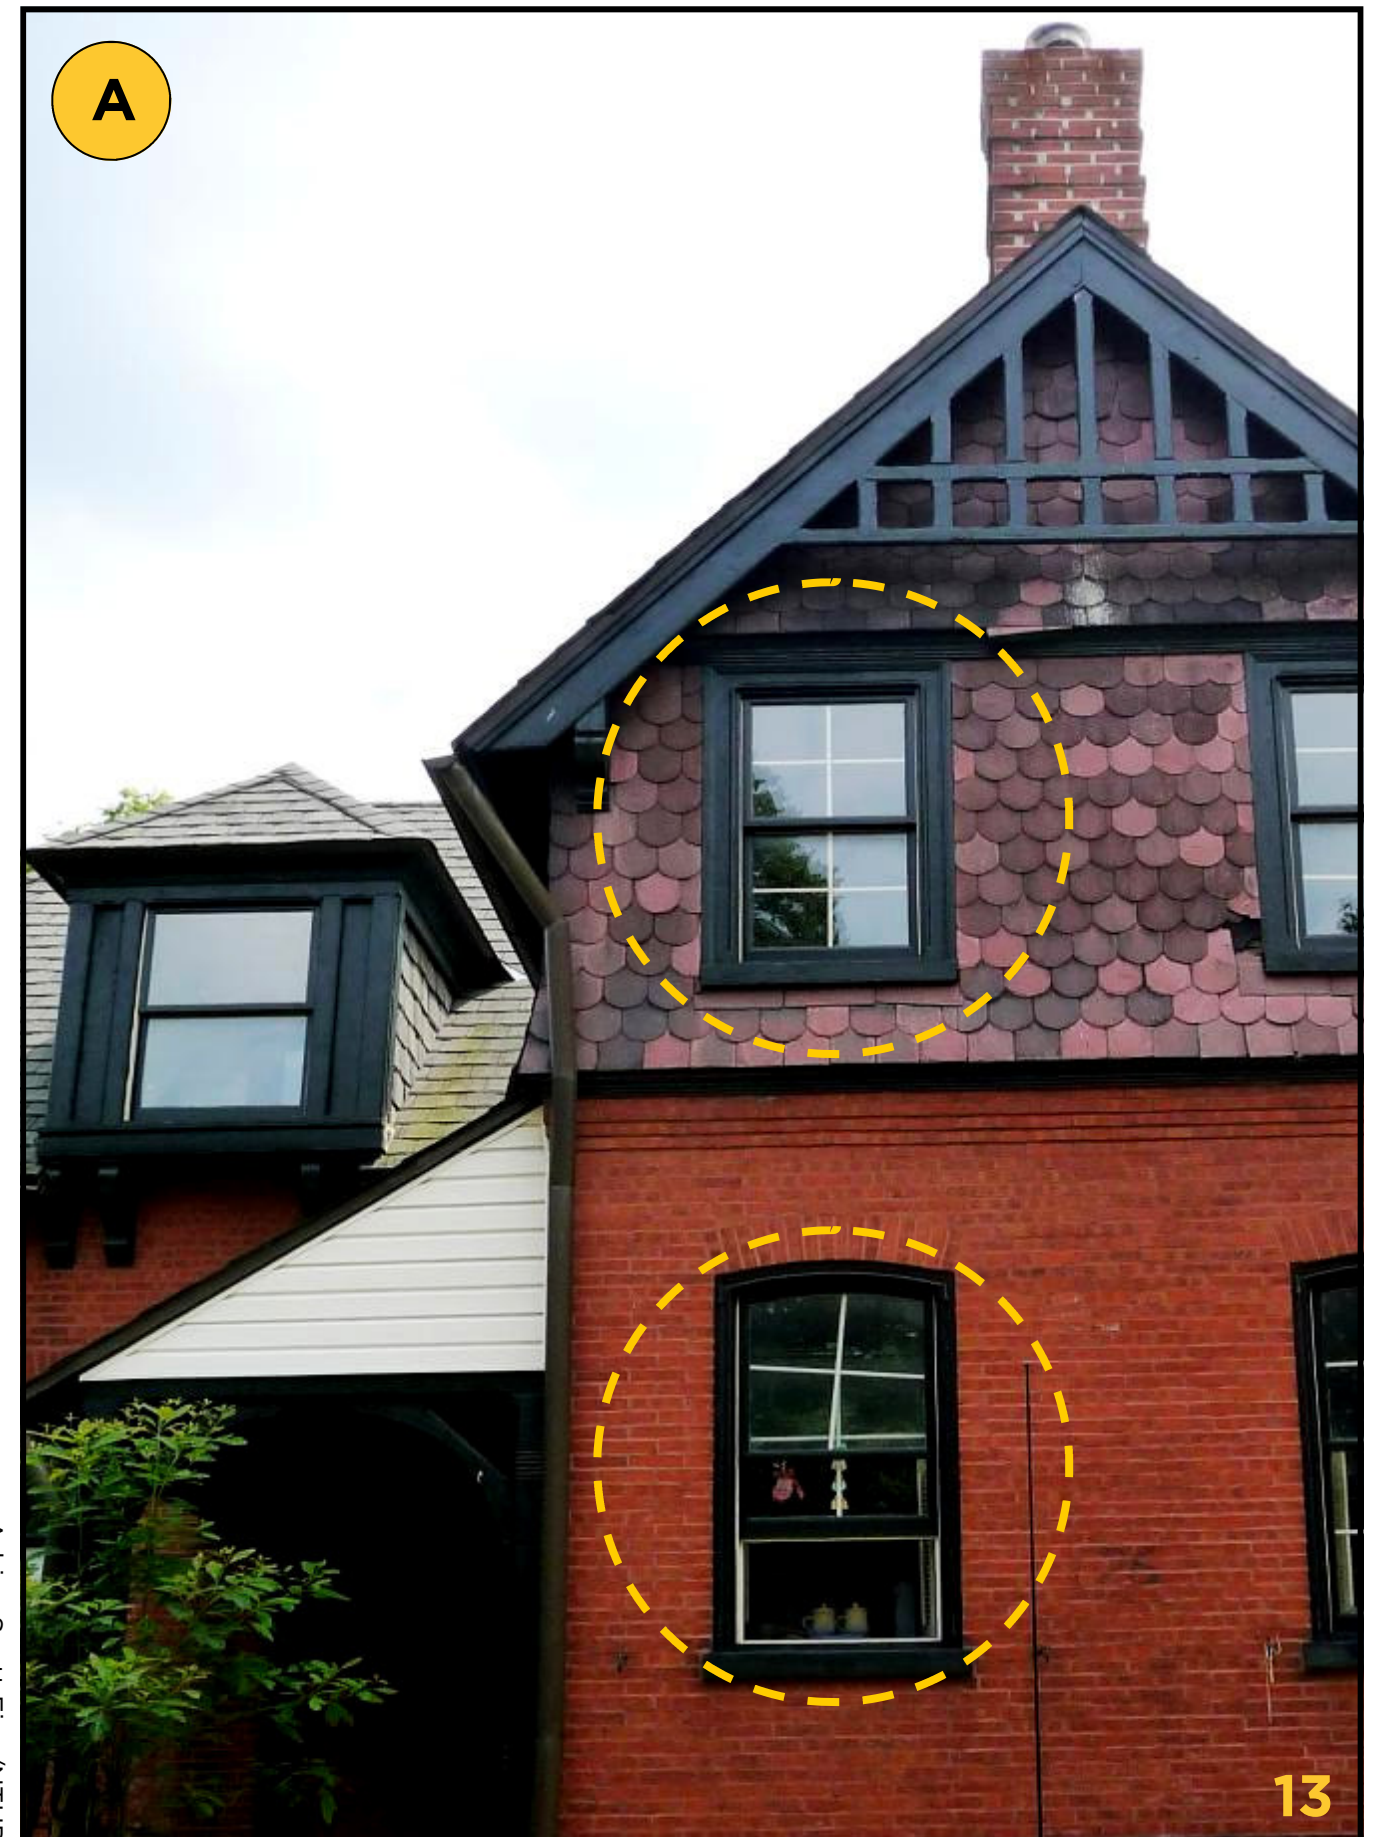
- A A former carriage house, rehabilitated and preserved for a new use, features replacement windows that attempt to look like true divided-light windows.
- B This four-over-four double-hung sash still has its original wood casing with a replacement window with clipped on interior muntins. There is little dimension or depth with this design and instead looks like a one-over-one sash.
- C This shows how clipped on interior muntins can loosen or fall off.
