NATIONAL  
TRUST  
FOR  
HISTORIC  
PRESERVATION®

# Repair or Replace Old Windows

**A Visual Look at the Impacts**

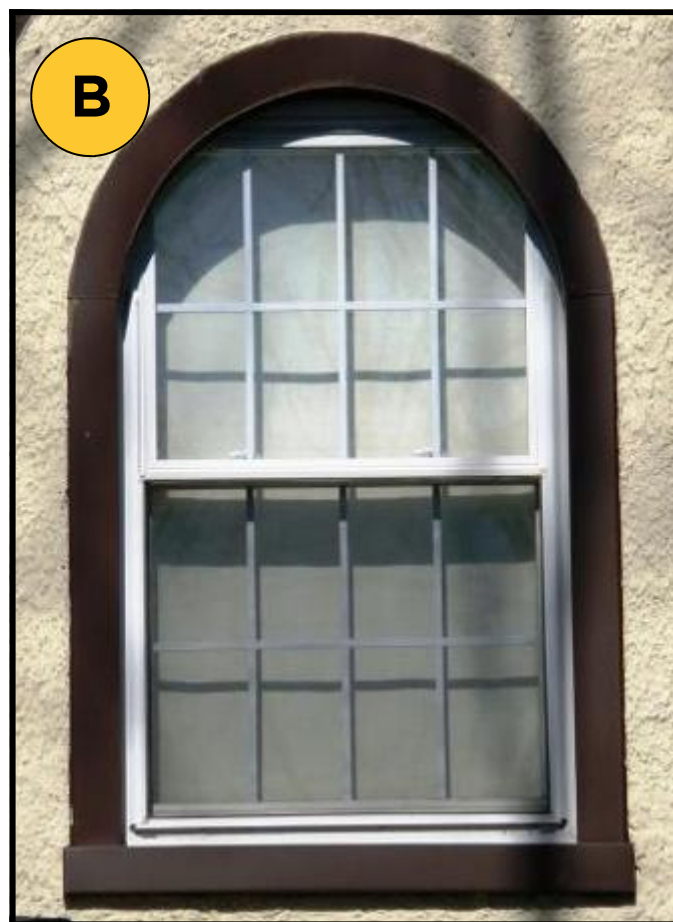
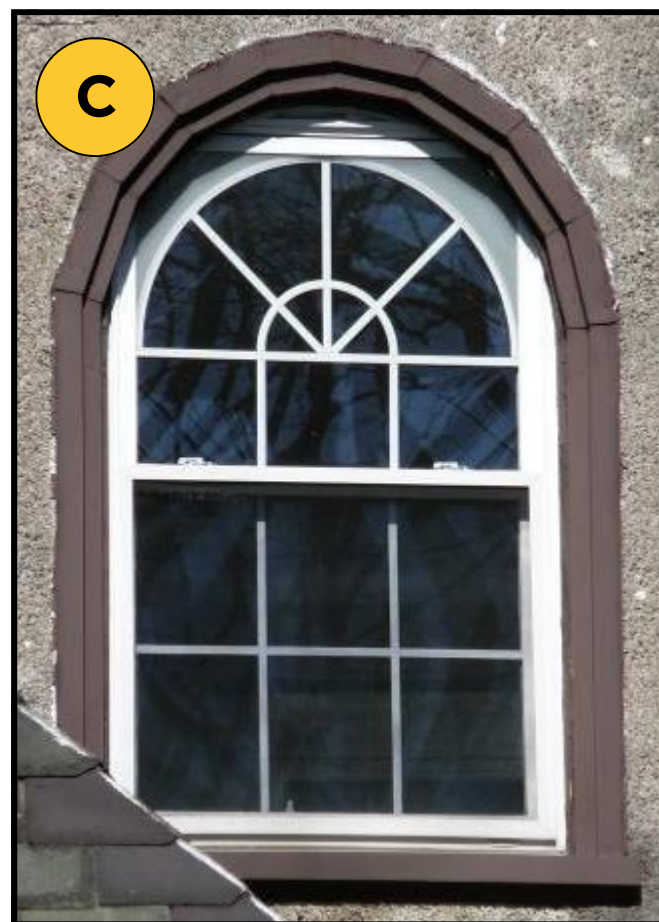
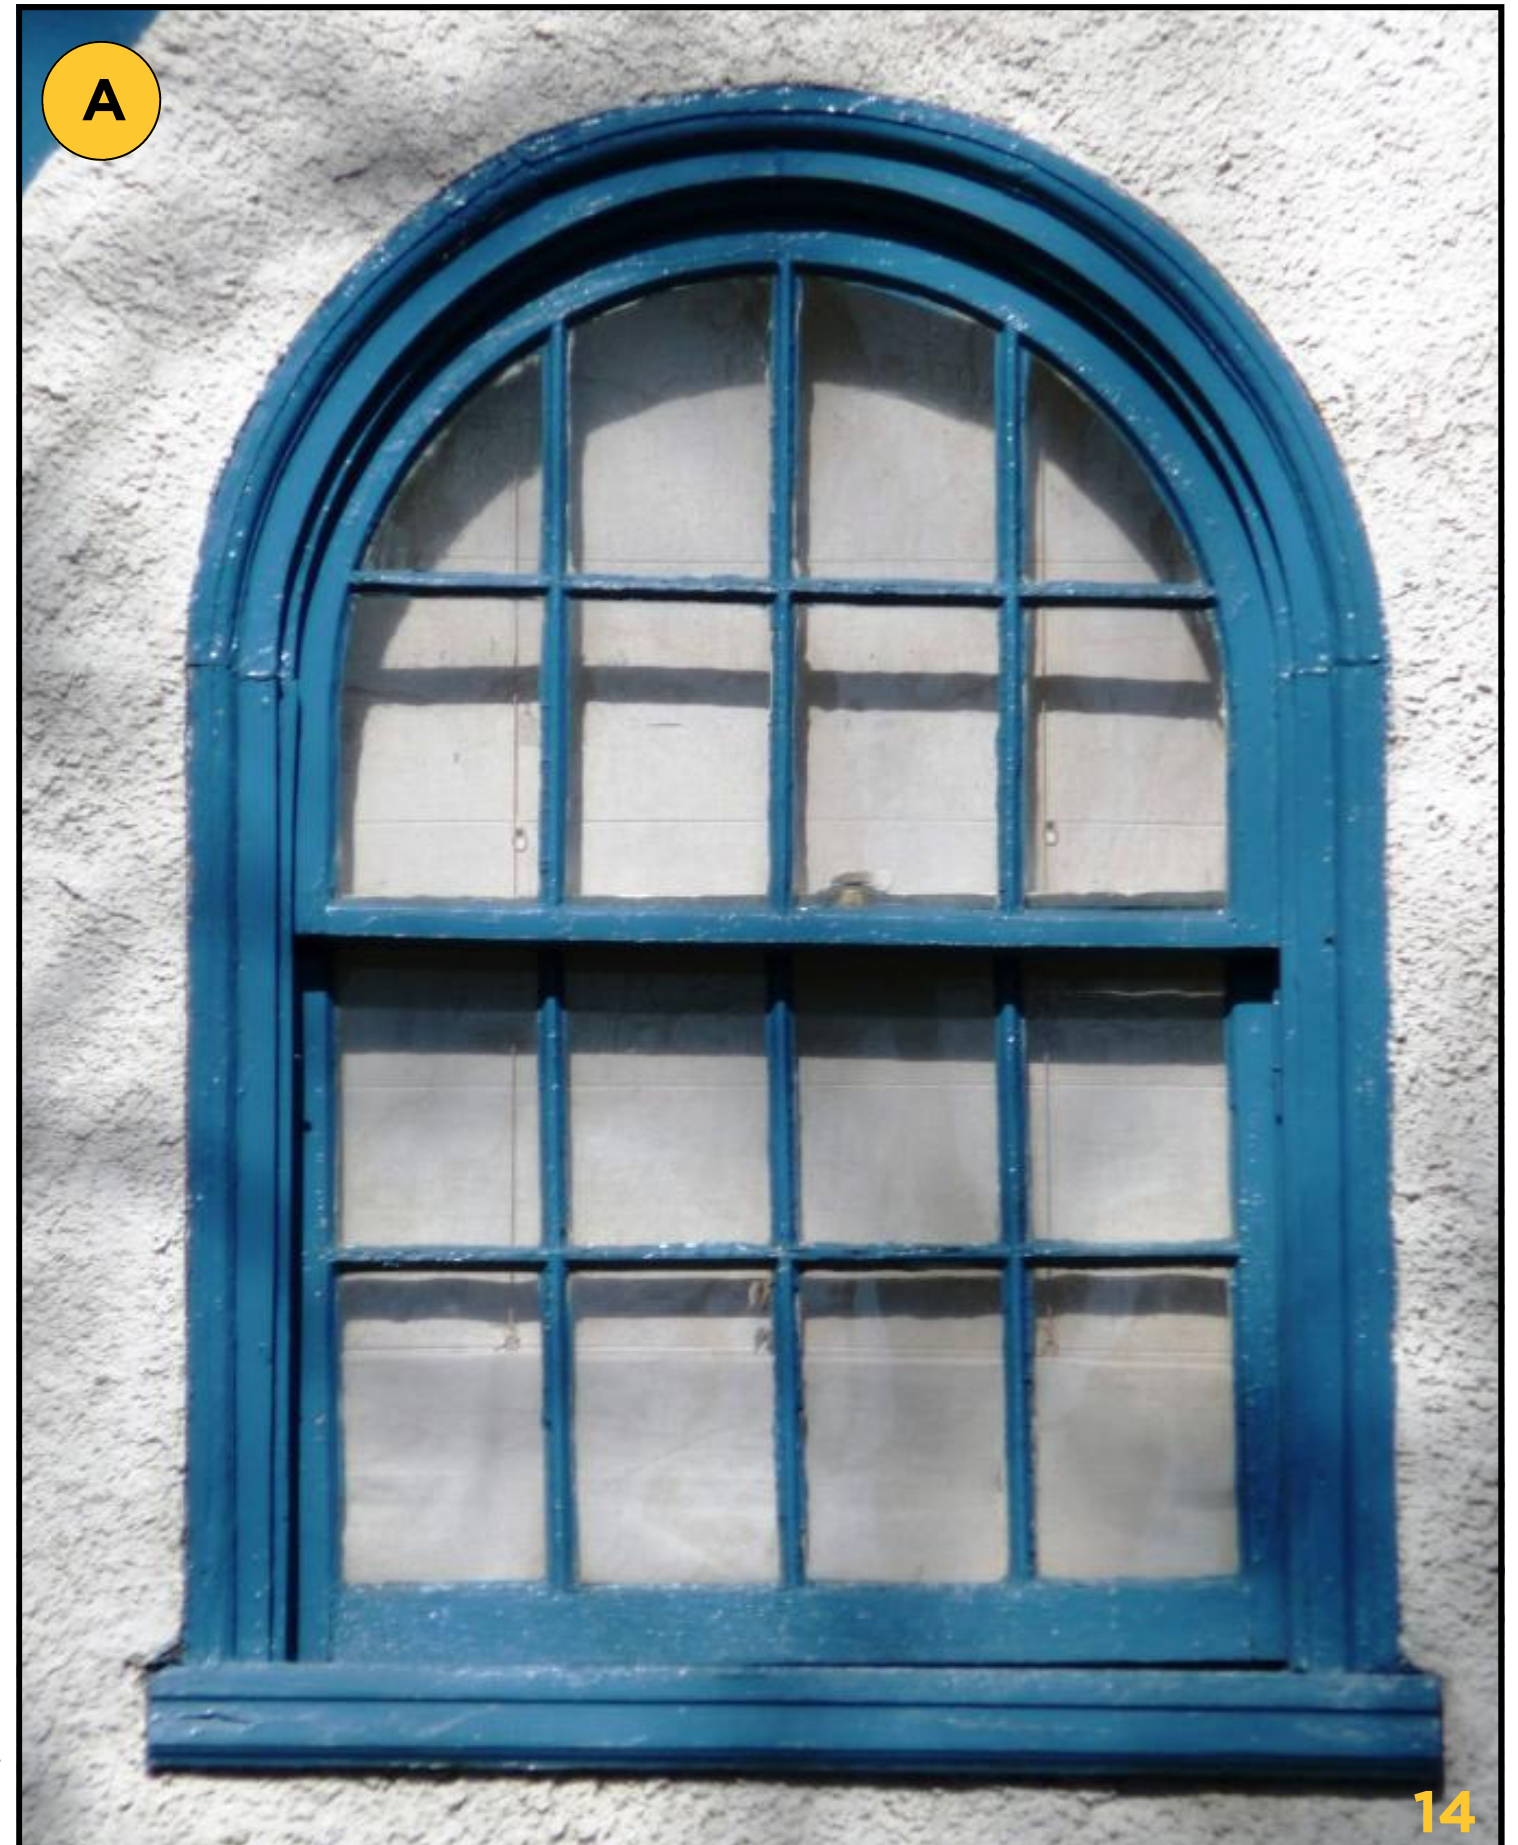
- A This eight-over-eight double-hung sash window with wood casing and sill is a common feature on houses in this neighborhood.
- B This replacement window attempts to replicate details of the original. However, it is not a true divided-light, the casing is wrapped in aluminum and the upper sash is flat and not round arched.
- C This replacement tries to look like a round arched window but is instead flat, features a completely different muntin pattern, has casing wrapped in aluminum and is not a true divided-light.

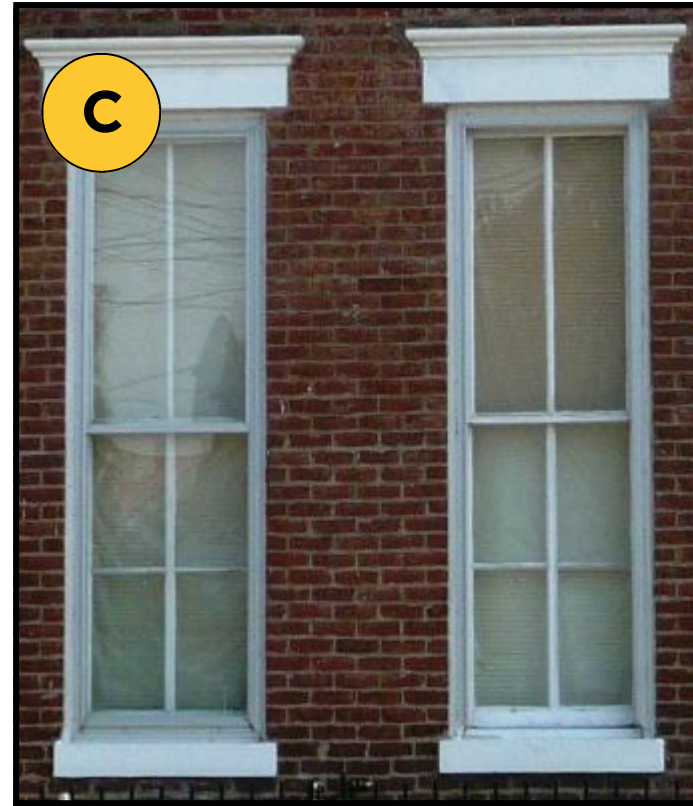
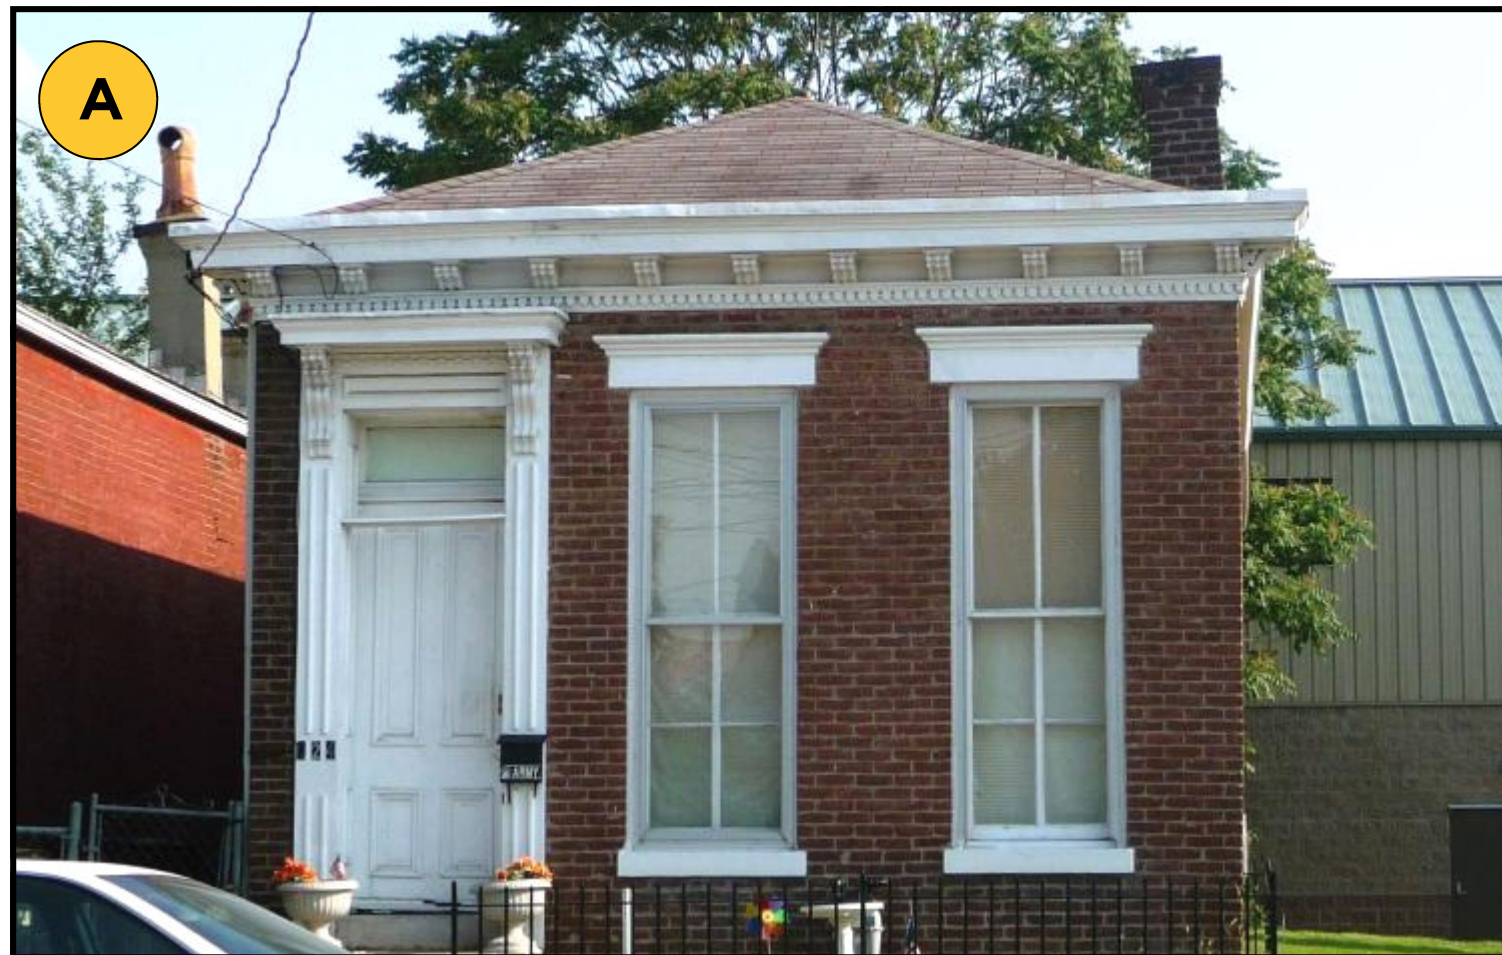
- A, B Two simple Shotgun style homes that were once nearly identical, to each other, and throughout the neighborhood.
- C Original two-over-two double-hung windows are a very prominent feature of these homes, directly relating to the size of the main entrance.
- D. The original windows were replaced, the openings reduced, and stock windows installed that are no longer in scale to the proportions of the house.

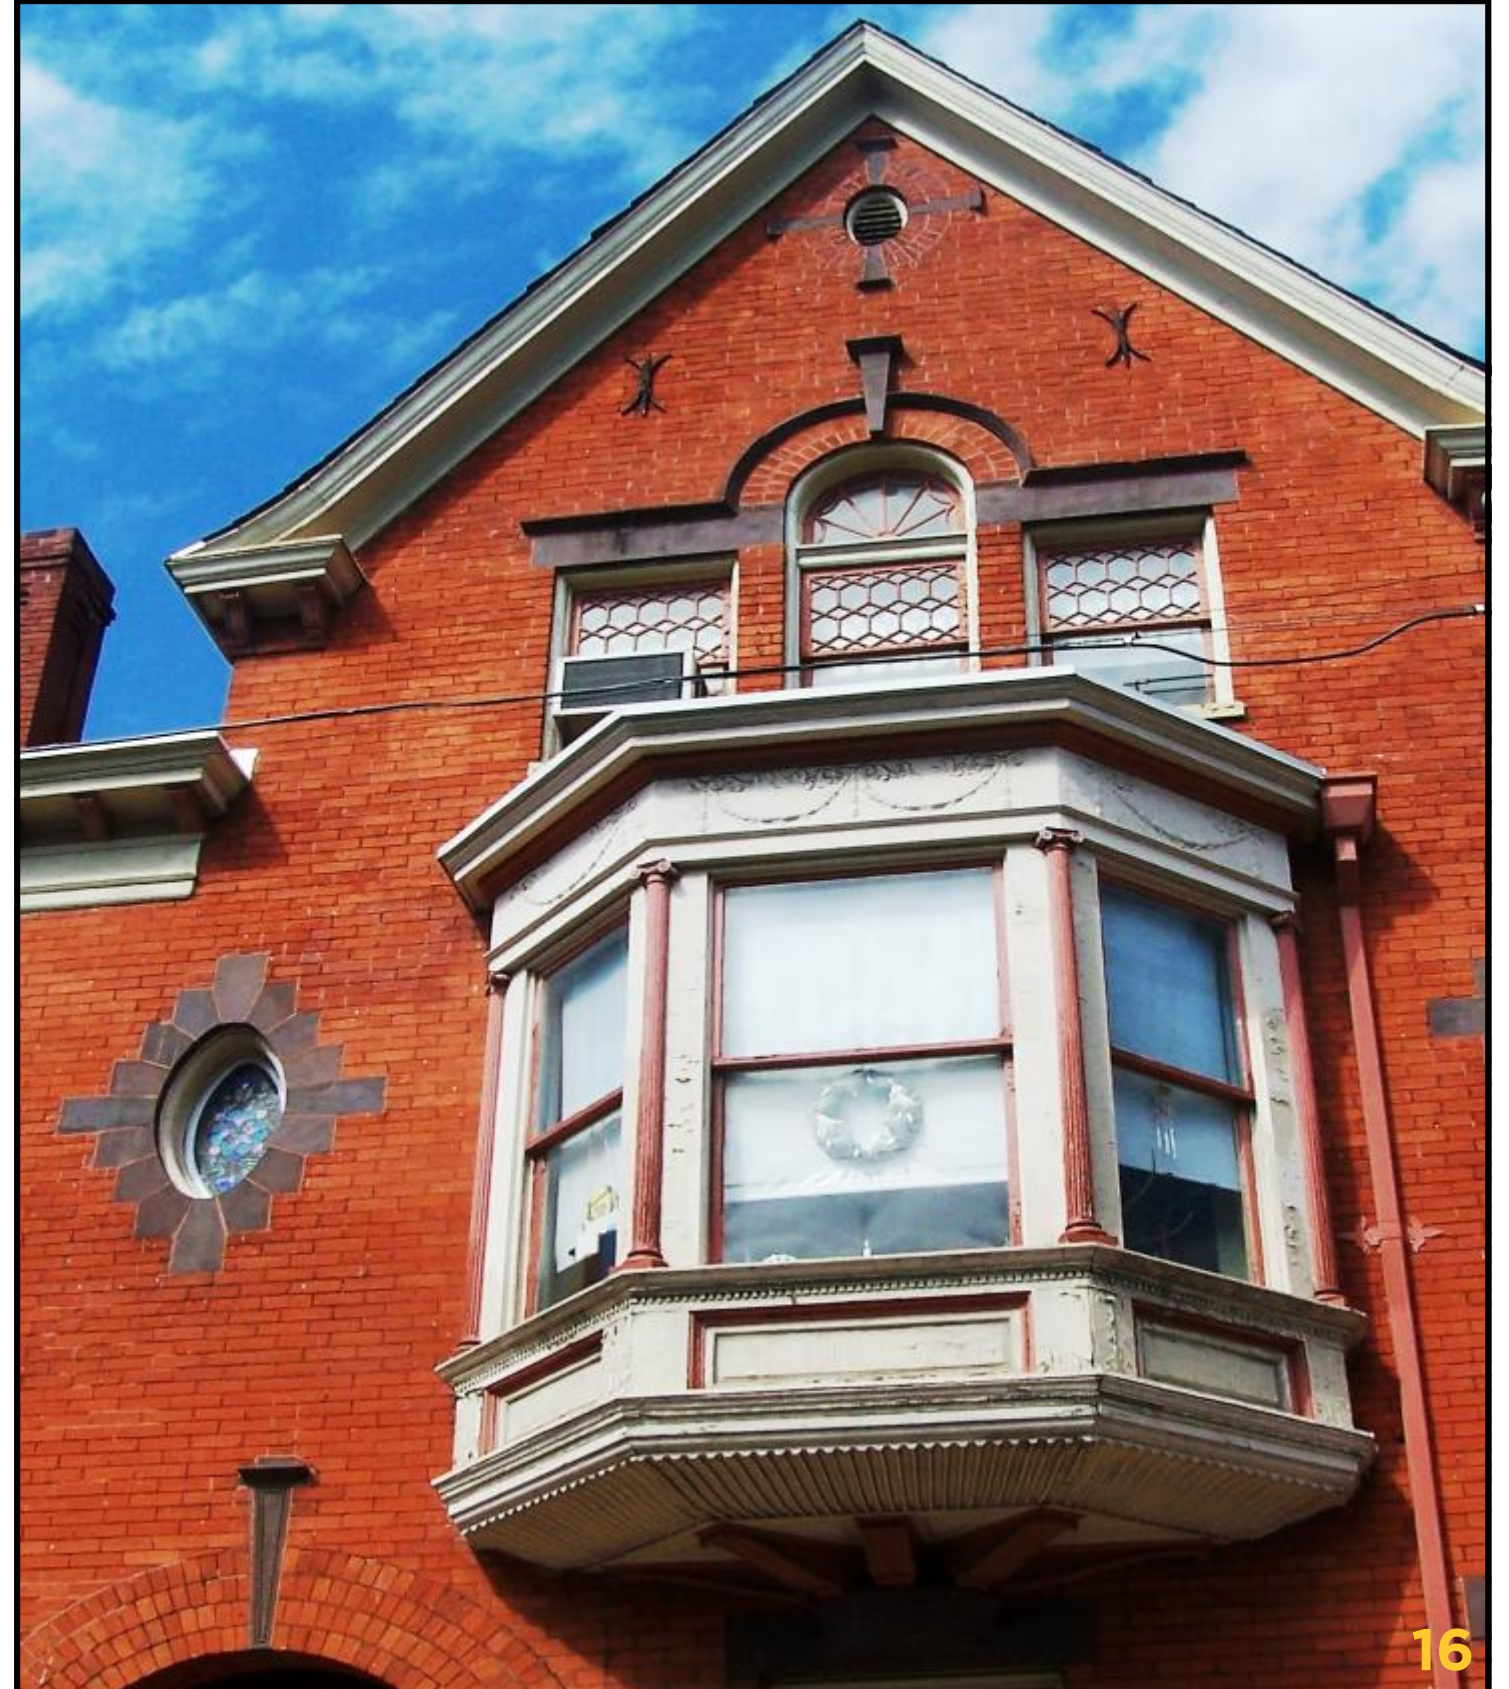
Early 20th century Queen Anne style house  
Original windows help define the character of older buildings
